General Information

Make	Toyota	Model	Vios
YOM	2023	Odo Meter Reading	57,333
Registration No.	FAN9238	Chassis No.	PA1B18F35P4200319
CC	1.3	Transmission	CVT
Fuel Type	Gas	Type of Body	Sedan
Colour	Black

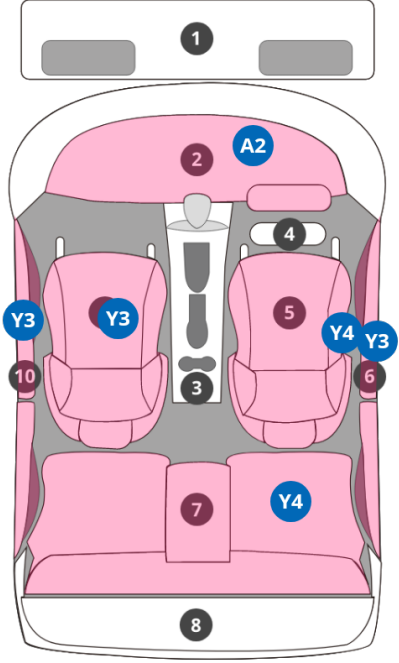
Interior Evaluation : C	Exterior Evaluation : D

<p>a : Cut, Fray d : Loose, Deformed k : Animal Hair s : Smell t : Cigarette Burns x : Defective y : Stain</p>

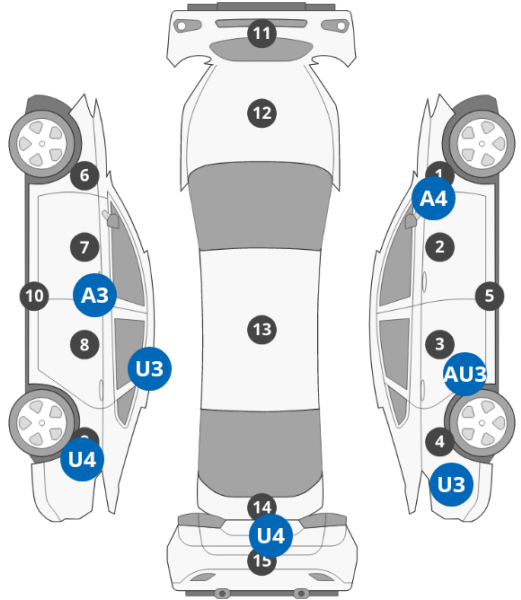
<p>A : Scratch AU : Scratch & Dent B : Modified C : Corrosion G : Stone chip P : Faded S : Rust SC : Rust & Corrosion U : Dent X : Defective Y : Crack, Gap</p>
<p>Remarks (R) Front Trim - Grime - Medium / (L) Front Trim - Grime - Medium / (L) Front Seat - Grime - Medium / (R) Front Seat - Grime - Large / Dashboard - Worn, Scratch, Cut, Crack - Small / Rear Seat - Grime - Large</p>	<p>Remarks (R) Front Door - Repair Traces - Yes / Bonnet - Repair Traces - Yes / (L) Front Door - Repair Traces - Yes / (L) Rear Door - Repair Traces - Yes / Trunk Hood, Rear Gate - Dent - Large / (L) Rear Fender, Molding - Dent - Large / (L) Rear Door, Molding - Dent - Medium / (R) Front Door, Molding - Scratch - Large / (L) Front Door, Molding - Scratch - Medium / (R) Rear Fender, Molding - Dent - Medium / (R) Rear Door, Molding - Scratch & Dent - Medium</p>
