General Information

Make	Toyota	Model	Vios
YOM	2022	Odo Meter Reading	87,101
Registration No.	EAF1013	Chassis No.	PA1B18F35N4169358
CC	1.3	Transmission	CVT
Fuel Type	Gas	Type of Body	Sedan
Colour	Red Mica Metallic

Body / Panel Condition

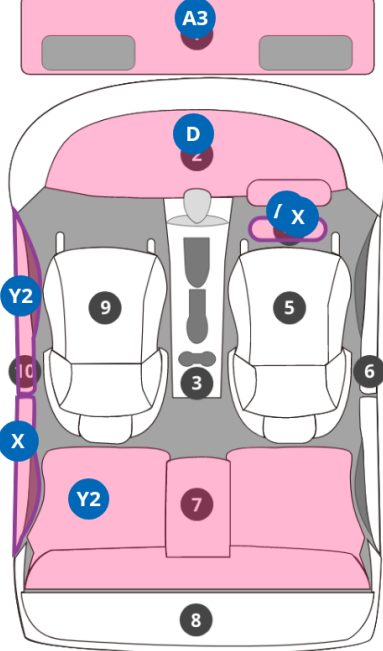
Interior Evaluation : B	Exterior Evaluation : E

<p>a : Cut, Fray d : Loose, Deformed k : Animal Hair s : Smell t : Cigarette Burns x : Defective y : Stain</p>

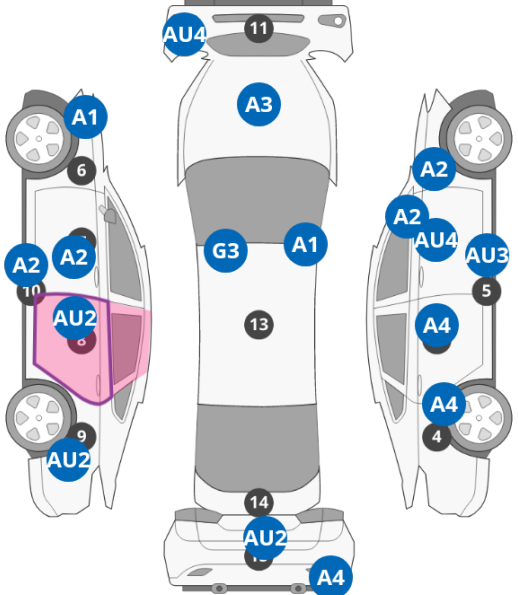
<p>A : Scratch AU : Scratch & Dent B : Modified C : Corrosion G : Stone chip P : Faded S : Rust SC : Rust & Corrosion U : Dent X : Defective Y : Crack, Gap</p>
<p>Remarks Ceiling - Cut, Crack - Medium / (L) Front Floor Mat - Cut, Crack - Small / Mat Other - Missing - Yes / Rear Seat - Grime - Small / (L) Front Trim - Grime - Small / Dashboard - Traces of Adhesive Tape - Yes / (L) Rear Trim - Missing - Yes</p>	<p>Remarks (R) Step - Repair Traces - Yes / (L) Rear Door - Repair Traces - Yes / (R) Rear Fender - Repair Traces - Yes / Roof - Repair Traces - Yes / (R) Front Fender, Molding - Scratch - Small / (R) Mirror - Scratch - Small / (R) Front Door, Molding - Scratch & Dent - Large / (R) Rear Door, Molding - Scratch - Large / (R) Step, In-panel, Side Spoiler - Scratch & Dent - Medium / (R) Rear Fender, Molding - Scratch - Large / Rear Bumper, Lamps, Panels - Scratch - Large / Trunk Hood, Rear Gate - Scratch & Dent - Small / (L) Rear Door, Molding - Repair mark - Difference in Color / (L) Rear Fender, Molding - Scratch & Dent - Small / (L) Rear Door, Molding - Scratch & Dent - Small / (L) Front Door, Molding - Scratch - Small / (L) Step, In-panel, Side Spoiler - Scratch - Small / Front Windshield - Scratch, Stone chip - Medium / (L) Front Fender, Molding - Scratch - Minimal / Front Bumper, Grille, Lamps - Scratch & Dent - Large / Roof - Scratch - Minimal / Bonnet, Headlight - Scratch - Medium</p>

<p>Inspector Notes</p>
<p>With Lto plate, 1key, no warranty booklet, no spare tire, no jack and tools, scratches on headlights and taillights, battery weak, plate light issue, L rear door issue</p>
