General Information

Make	Toyota	Model	Vios
YOM	2021	Odo Meter Reading	44,244
Registration No.	DAP2159	Chassis No.	PA1B18F30M41850485
CC	1.3	Transmission	CVT
Fuel Type	Gas	Type of Body	Sedan
Colour	Red Mica Metallic

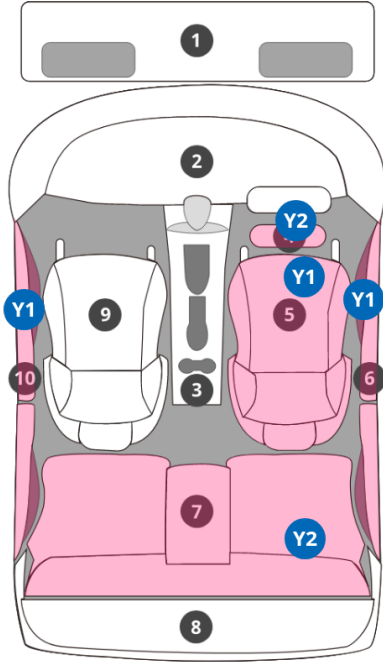
Interior Evaluation : A	Exterior Evaluation : E

<p>a : Cut, Fray d : Loose, Deformed k : Animal Hair s : Smell t : Cigarette Burns x : Defective y : Stain</p>

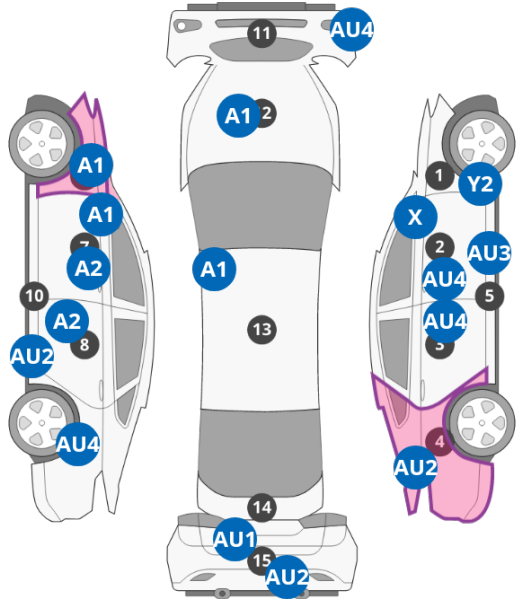
<p>A : Scratch AU : Scratch & Dent B : Modified C : Corrosion G : Stone chip P : Faded S : Rust SC : Rust & Corrosion U : Dent X : Defective Y : Crack, Gap</p>
<p>Remarks (L) Front Floor Mat - Grime - Small / (L) Front Trim - Grime - Minimal / (R) Front Trim - Grime - Minimal / (R) Front Seat - Grime - Minimal / Rear Seat - Grime - Small</p>	<p>Remarks (L) Front Fender - Repair Traces - Yes / (R) Rear Fender - Repair Traces - Yes / (R) Front Fender, Molding - Crack, Gap - Small / (R) Mirror - Stuck - Yes / (R) Front Door, Molding - Scratch & Dent - Large / (R) Rear Door, Molding - Scratch & Dent - Large / (R) Step, In-panel, Side Spoiler - Scratch & Dent - Medium / (R) Rear Fender, Molding - Repair mark - Yes / (R) Rear Fender, Molding - Scratch & Dent - Small / Trunk Hood, Rear Gate - Scratch & Dent - Minimal / Rear Bumper, Lamps, Panels - Scratch & Dent - Small / (L) Rear Fender, Molding - Scratch & Dent - Large / (L) Step, In-panel, Side Spoiler - Scratch & Dent - Small / (L) Rear Door, Molding - Scratch - Small / (L) Mirror - Scratch - Minimal / (L) Front Door, Molding - Scratch - Small / Roof - Scratch - Minimal / (L) Front Fender, Molding - Repair mark - Yes / (L) Front Fender, Molding - Scratch - Minimal / Front Bumper, Grille, Lamps - Scratch & Dent - Large / Bonnet, Headlight - Scratch - Minimal</p>
