## General Information

<b>Make</b>	Toyota	<b>Model</b>	Wigo
<b>YOM</b>	2021	<b>Odo Meter Reading</b>	37,150
<b>Registration No.</b>	NEW3404	<b>Chassis No.</b>	MKA4DF5FMJ057399
<b>CC</b>	1.0	<b>Transmission</b>	A/T
<b>Fuel Type</b>	Gas	<b>Type of Body</b>	Hatchback
<b>Colour</b>	Gray

## Body / Panel Condition

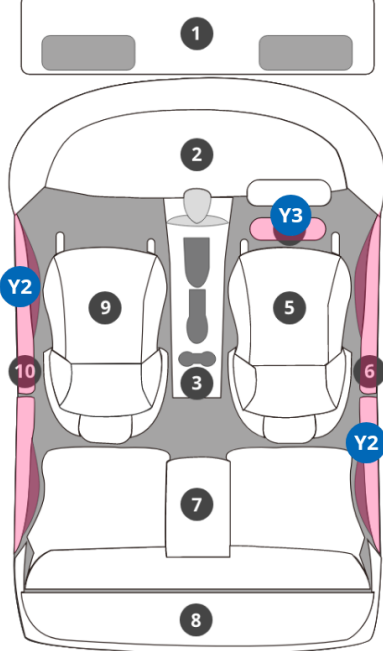
<b>Interior Evaluation :</b> <span style="float: right; color: red; font-weight: bold;">B</span>	<b>Exterior Evaluation :</b> <span style="float: right; color: red; font-weight: bold;">D</span>

<p><b>a</b> : Cut, Fray <b>d</b> : Loose, Deformed <b>k</b> : Animal Hair <b>s</b> : Smell <b>t</b> : Cigarette Burns <b>x</b> : Defective <b>y</b> : Stain</p>

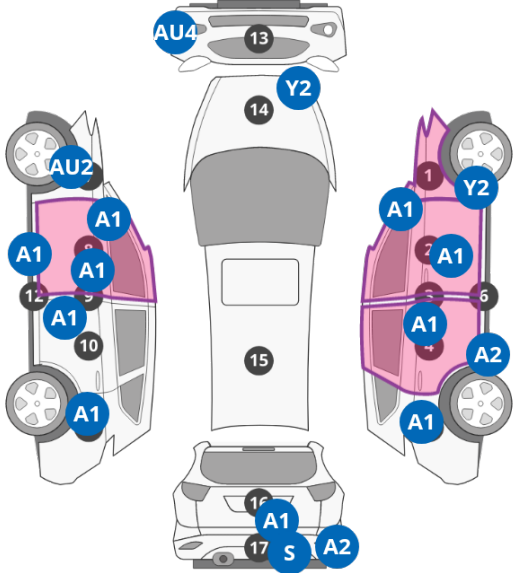
<p><b>A</b> : Scratch <b>AU</b> : Scratch &amp; Dent <b>B</b> : Modified <b>C</b> : Corrosion <b>G</b> : Stone chip <b>P</b> : Faded <b>S</b> : Rust <b>SC</b> : Rust &amp; Corrosion <b>U</b> : Dent <b>X</b> : Defective <b>Y</b> : Crack, Gap</p>
<p><b>Remarks</b> (L) Front Trim - Grime - Small / (R) Rear Trim - Grime - Small / (R) Front Floor Mat - Grime - Medium</p>	<p><b>Remarks</b> (R) Front Fender - Repair Traces - Yes / (L) Front Fender - Repair Traces - Yes / (R) Front Door, Molding - Repair mark - Yes / (R) Front Fender, Molding - Repair mark - Yes / (R) Front Fender, Molding - Crack, Gap - Small / (R) Rear Door, Molding - Repair mark - Yes / (R) Mirror - Scratch - Minimal / (R) Front Door, Molding - Scratch - Minimal / (R) Step, In-panel, Side Spoiler - Scratch - Small / (R) Rear Door, Molding - Scratch - Minimal / Trunk Hood, Rear Gate - Scratch - Minimal / Rear Bumper, Lamps, Panels - Scratch - Small / (R) Rear Fender, Molding - Scratch - Minimal / (L) Rear Fender, Molding - Scratch - Minimal / (L) Rear Door, Molding - Scratch - Minimal / (L) Mirror - Scratch - Minimal / (L) Front Door, Molding - Repair mark - Yes / (L) Front Door, Molding - Scratch - Minimal / (L) Step, In-panel, Side Spoiler - Scratch - Minimal / (L) Front Fender, Molding - Scratch &amp; Dent - Small / Front Bumper, Grille, Lamps - Scratch &amp; Dent - Large / Bonnet, Headlight - Crack, Gap - Small / Muffler and Undercarriage Parts - Rust - Yes</p>

<p><b>Inspector Notes</b></p>
<p>With Lto plate, with spare tire, 1key, no warranty booklet, no jack and tools, scratches on taillight, crack headlight, muffler issue,</p>
