General Information

Make	Toyota	Model	Fortuner
YOM	2024	Odo Meter Reading	40,273
Registration No.	GBC2516	Chassis No.	MHFBA3FS7P1053304
CC	2.8	Transmission	A/T
Fuel Type	Diesel	Type of Body	SUV
Colour	White

Body / Panel Condition

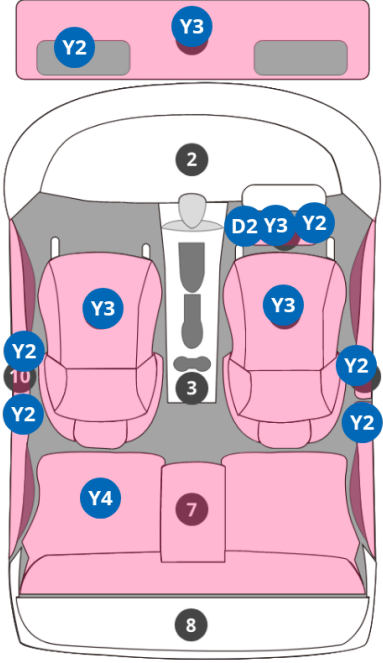
Interior Evaluation : D	Exterior Evaluation : D

<p>a : Cut, Fray d : Loose, Deformed k : Animal Hair s : Smell t : Cigarette Burns x : Defective y : Stain</p>

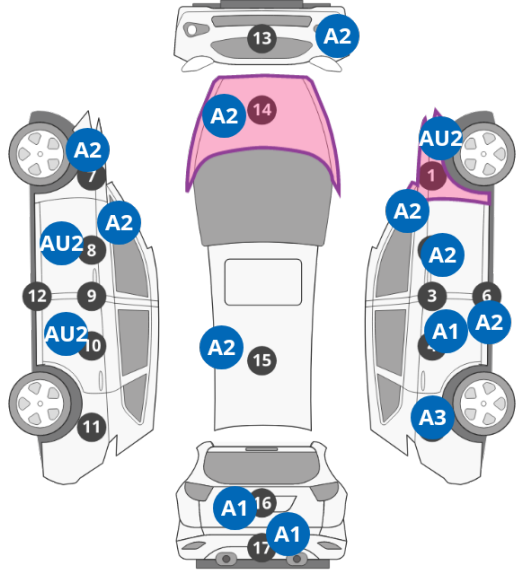
<p>A : Scratch AU : Scratch & Dent B : Modified C : Corrosion G : Stone chip P : Faded S : Rust SC : Rust & Corrosion U : Dent X : Defective Y : Crack, Gap</p>
<p>Remarks (R) Front Floor Mat - Grime - Small / (R) Front Seat - Grime - Medium / (R) Front Trim - Grime - Small / (R) Rear Trim - Grime - Small / Mat Other - Grime - Medium / Ceiling - Grime - Medium / Rear Seat - Grime - Large / (L) Rear Trim - Grime - Small / (L) Front Trim - Grime - Small / (L) Front Floor Mat - Worked - Small / (L) Front Seat - Grime - Medium / Sunvisor, Sunglass Holder - Grime - Small</p>	<p>Remarks (R) Front Fender - Repair Traces - Yes / Bonnet - Repair Traces - Yes / Roof - Repair Traces - Yes / (L) Front Fender, Molding - Scratch - Small / (L) Mirror - Scratch - Small / (L) Front Door, Molding - Scratch & Dent - Small / (L) Rear Door, Molding - Scratch & Dent - Small / Rear Bumper, Lamps, Panels - Scratch - Minimal / Trunk Hood, Rear Gate - Scratch - Minimal / (R) Rear Fender, Molding - Scratch - Medium / (R) Step, In-panel, Side Spoiler - Scratch - Small / (R) Front Door, Molding - Scratch - Small / (R) Rear Door, Molding - Scratch - Minimal / (R) Front Fender, Molding - Scratch & Dent - Small / (R) Mirror - Scratch - Small / Bonnet, Headlight - Scratch - Small / Front Bumper, Grille, Lamps - Scratch - Small / Bonnet, Headlight - Repair mark - Yes / (R) Front Fender, Molding - Repair mark - Yes / Roof - Scratch - Small</p>
