General Information

Make	Toyota	Model	Vios
YOM	2026	Odo Meter Reading	8,669
Registration No.	GBK8194	Chassis No.	PA1B18F32S4294927
CC	1.3	Transmission	CVT
Fuel Type	Gas	Type of Body	Sedan
Colour	Black

Body / Panel Condition

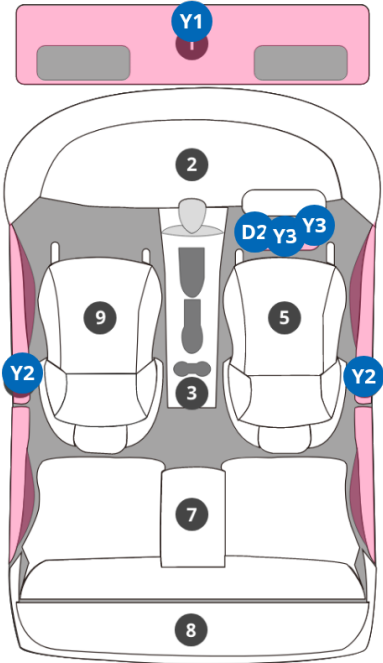
Interior Evaluation : B	Exterior Evaluation : E

<p>a : Cut, Fray d : Loose, Deformed k : Animal Hair s : Smell t : Cigarette Burns x : Defective y : Stain</p>

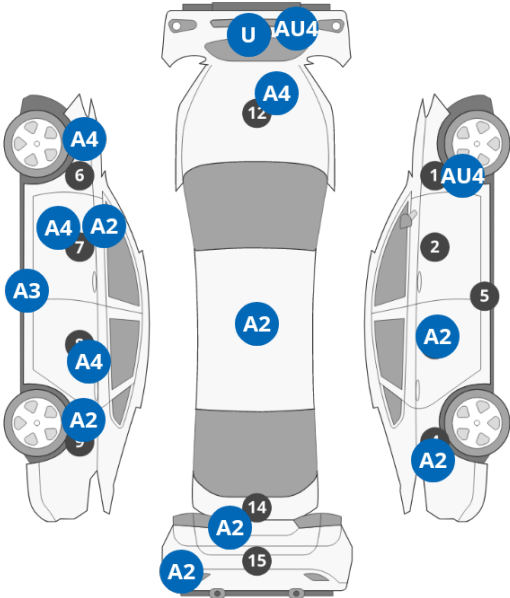
<p>A : Scratch AU : Scratch & Dent B : Modified C : Corrosion G : Stone chip P : Faded S : Rust SC : Rust & Corrosion U : Dent X : Defective Y : Crack, Gap</p>
<p>Remarks (L) Front Trim - Grime - Small / (L) Front Floor Mat - Worked - Small / Ceiling - Grime - Minimal / Mat Other - Grime - Medium / (R) Front Trim - Grime - Small / (R) Front Floor Mat - Grime - Medium</p>	<p>Remarks Trunk Hood, Rear Gate - Repair Traces - Yes / (L) Front Fender, Molding - Scratch - Large / (L) Mirror - Scratch - Small / (L) Front Door, Molding - Scratch - Large / (L) Rear Door, Molding - Scratch - Large / (L) Rear Fender, Molding - Scratch - Small / (L) Step, In-panel, Side Spoiler - Scratch - Medium / Trunk Hood, Rear Gate - Scratch - Small / Rear Bumper, Lamps, Panels - Scratch - Small / (R) Rear Fender, Molding - Scratch - Small / (R) Rear Door, Molding - Scratch - Small / (R) Front Fender, Molding - Scratch & Dent - Large / Front Bumper, Grille, Lamps - Scratch & Dent - Large / Member (Bolted) - Dent - Yes / Bonnet, Headlight - Scratch - Large / Roof - Scratch - Small</p>

<p>Inspector Notes</p>
<p>With LTO apprehension. Possible flooding. Gap at front bumper, Front fenders and bonnet. Scratches at headlight and taillight. With warranty booklet, spare tire, and seat cover. Incomplete tools. Without jack. 1 key. With LTO plate.</p>
