General Information

Make	Toyota	Model	Hilux Tamaraw
YOM	2026	Odo Meter Reading	2,247
Registration No.	CCQ6838	Chassis No.	PAHACACA6S6429932
CC	2.4	Transmission	M/T
Fuel Type	Diesel	Type of Body	Utility Vehicle
Colour	White

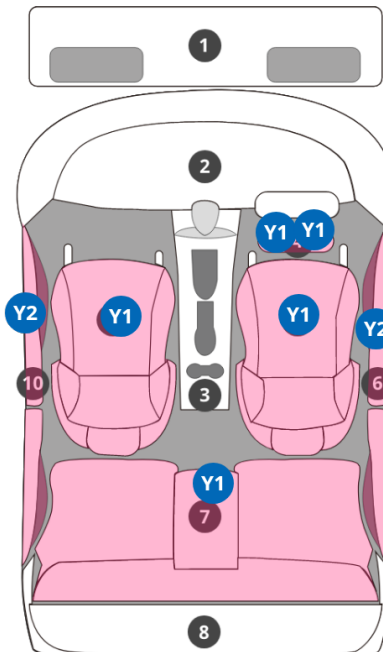
Interior Evaluation : A	Exterior Evaluation : D

<p>a : Cut, Fray d : Loose, Deformed k : Animal Hair s : Smell t : Cigarette Burns x : Defective y : Stain</p>

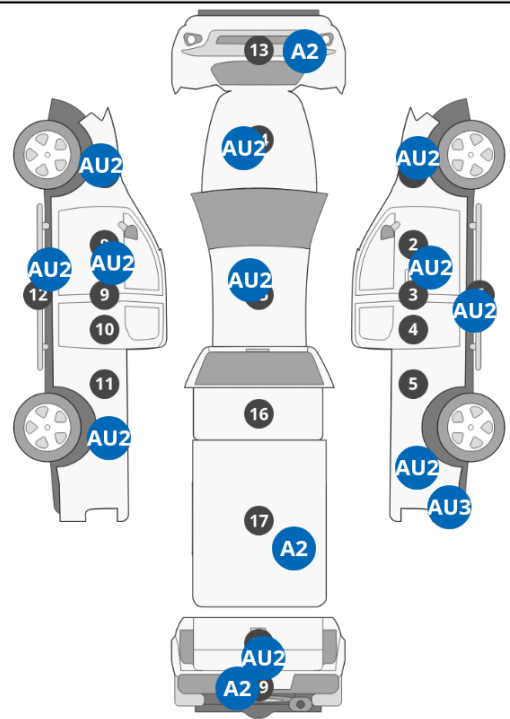
<p>A : Scratch AU : Scratch & Dent B : Modified C : Corrosion G : Stone chip P : Faded S : Rust SC : Rust & Corrosion U : Dent X : Defective Y : Crack, Gap</p>
<p>Remarks (L) Front Floor Mat - Grime - Minimal / (R) Front Floor Mat - Grime - Minimal / (L) Front Seat - Grime - Minimal / (R) Front Seat - Grime - Minimal / (L) Front Trim - Grime - Small / (R) Front Trim - Grime - Small / Rear Seat - Grime - Minimal</p>	<p>Remarks Roof - Repair Traces - Yes / Bonnet, Headlight - Scratch & Dent - Small / (L) Front Fender, Molding - Scratch & Dent - Small / (L) Front Door, Molding - Scratch & Dent - Small / (L) Step, In-panel, Side Spoiler - Scratch & Dent - Small / (L) Side Gate - Scratch & Dent - Small / Rear Gate - Scratch & Dent - Small / Rear Bumper, Lamps, Panels - Scratch - Small / (R) Guard Frame - Scratch & Dent - Medium / (R) Side Gate - Scratch & Dent - Small / (R) Front Door, Molding - Scratch & Dent - Small / (R) Step, In-panel, Side Spoiler - Scratch & Dent - Small / (R) Front Fender, Molding - Scratch & Dent - Small / Roof - Scratch & Dent - Small / Front Bumper, Grille, Lamps - Scratch - Small / Cargo Bed Floor - Scratch - Small</p>

<p>Inspector Notes</p>
<p>with LTO plate, with Manual and warranty booklet, with spare tire, with tools & jack, scratches on taillight and headlight,</p>
