## General Information

| Make | Toyota | Model | Vios |
| YOM | 2022 | Mileage | 55,555 |
| Registration No. | NFJ5029 | Chassis No. | PA1B18F31N4171141 |

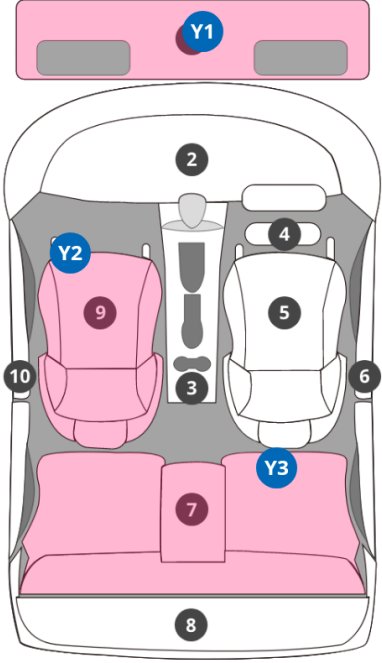
| <b>Interior Evaluation :</b> <span style="color: red; font-weight: bold;">B</span> | <b>Exterior Evaluation :</b> <span style="color: red; font-weight: bold;">C</span> |
| <b>Remarks</b><br>Ceiling - Grime - Minimal / Rear Seat - Grime - Medium / (L) Front Seat - Grime - Small | <b>Remarks</b><br>Rear Bumper, Lamps, Panels - Repair mark - Yes / (R) Front Door, Molding - Repair mark - Yes / (L) Front Door, Molding - Repair mark - Yes / (L) Front Fender, Molding - Dent - Small / (R) Rear Fender, Molding - Scratch & Dent - Minimal / (L) Rear Fender, Molding - Scratch - Small / Front Bumper, Grille, Lamps - Scratch - Large / (R) Front Fender, Molding - Dent - Medium |
