General Information

Make	Toyota	Model	Vios
YOM	2023	Odo Meter Reading	82,748
Registration No.	CBE9907	Chassis No.	PA1B18F35N4195913
CC	1.3	Transmission	CVT
Fuel Type	Gas	Type of Body	Sedan
Colour	Blackish Red Mica

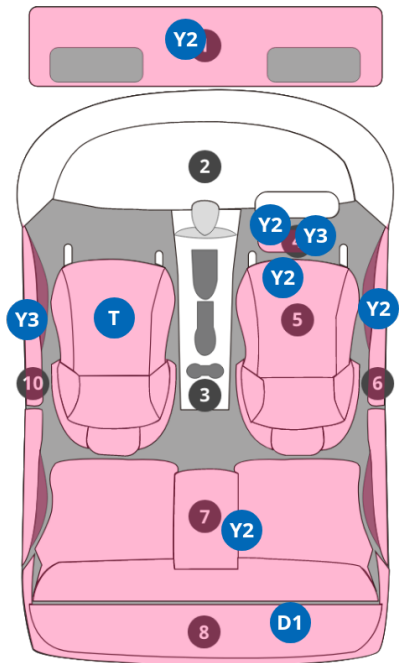
Interior Evaluation : C	Exterior Evaluation : E

<p>a : Cut, Fray d : Loose, Deformed k : Animal Hair s : Smell t : Cigarette Burns x : Defective y : Stain</p>

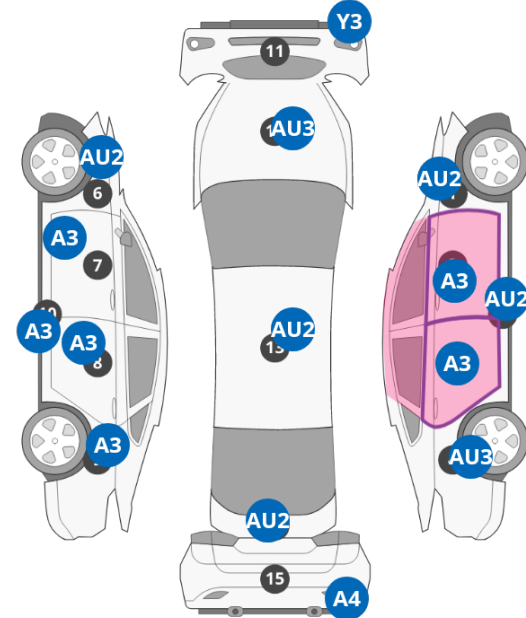
<p>A : Scratch AU : Scratch & Dent B : Modified C : Corrosion G : Stone chip P : Faded S : Rust SC : Rust & Corrosion U : Dent X : Defective Y : Crack, Gap</p>
<p>Remarks (L) Front Seat - Cigarette Burns - Burnt, Hole / (R) Front Seat - Grime - Small / (L) Front Trim - Grime - Medium / (R) Front Floor Mat - Grime - Medium / (L) Front Floor Mat - Grime - Small / Rear Seat - Grime - Small / (R) Front Trim - Grime - Small / Ceiling - Grime - Small / Trunk Room - Worked - Minimal</p>	<p>Remarks (R) Front Door - Repair Traces - Yes / (L) Front Fender - Repair Traces - Yes / Trunk Hood, Rear Gate - Scratch & Dent - Small / Rear Bumper, Lamps, Panels - Scratch - Large / (R) Rear Fender, Molding - Scratch & Dent - Medium / (R) Rear Door, Molding - Scratch - Medium / (R) Front Door, Molding - Scratch - Medium / (R) Step, In-panel, Side Spoiler - Scratch & Dent - Small / (R) Front Fender, Molding - Scratch & Dent - Small / (R) Rear Door, Molding - Repair mark - Yes / (R) Front Door, Molding - Repair mark - Yes / Bonnet, Headlight - Scratch & Dent - Medium / Front Bumper, Grille, Lamps - Crack, Gap - Medium / (L) Front Fender, Molding - Scratch & Dent - Small / (L) Front Door, Molding - Scratch - Medium / (L) Step, In-panel, Side Spoiler - Scratch - Medium / (L) Rear Door, Molding - Scratch - Medium / (L) Rear Fender, Molding - Scratch - Medium / Roof - Scratch & Dent - Small</p>
