General Information

Make	Toyota	Model	Vios
YOM	2023	Odo Meter Reading	24,685
Registration No.	CBT9867	Chassis No.	PA1B18F32P4210452
CC	1.3	Transmission	CVT
Fuel Type	Gas	Type of Body	Sedan
Colour	Blue

Body / Panel Condition

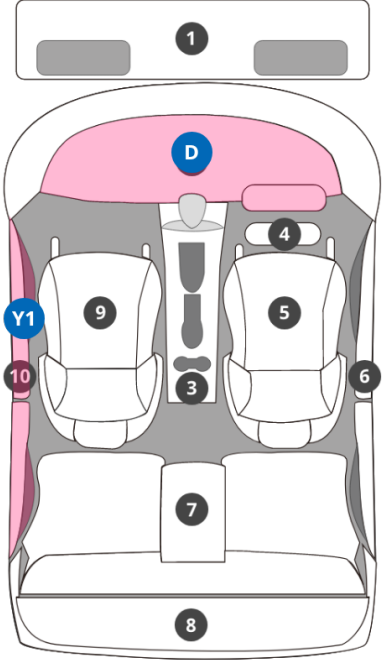
Interior Evaluation : A	Exterior Evaluation : C

<p>a : Cut, Fray d : Loose, Deformed k : Animal Hair s : Smell t : Cigarette Burns x : Defective y : Stain</p>

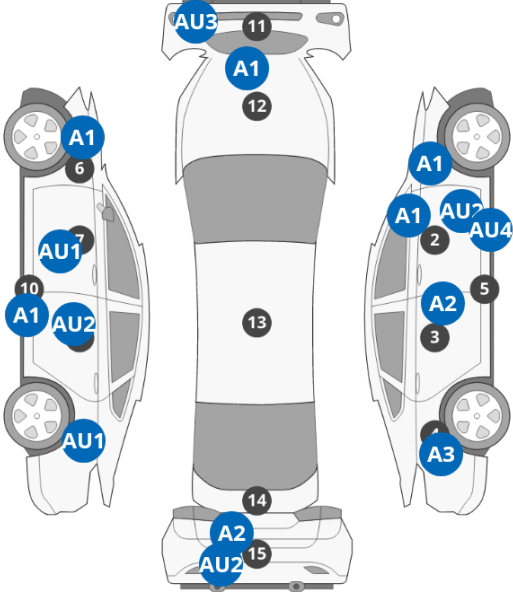
<p>A : Scratch AU : Scratch & Dent B : Modified C : Corrosion G : Stone chip P : Faded S : Rust SC : Rust & Corrosion U : Dent X : Defective Y : Crack, Gap</p>
<p>Remarks (L) Front Trim - Grime - Minimal / Dashboard - Traces of Adhesive Tape - Yes</p>	<p>Remarks (R) Front Fender, Molding - Scratch - Minimal / (R) Mirror - Scratch - Minimal / (R) Front Door, Molding - Scratch & Dent - Small / (R) Step, In-panel, Side Spoiler - Scratch & Dent - Large / (R) Rear Door, Molding - Scratch - Small / (R) Rear Fender, Molding - Scratch - Medium / Rear Bumper, Lamps, Panels - Scratch & Dent - Small / Trunk Hood, Rear Gate - Scratch - Small / (L) Rear Fender, Molding - Scratch & Dent - Minimal / (L) Rear Door, Molding - Scratch & Dent - Small / (L) Step, In-panel, Side Spoiler - Scratch - Minimal / (L) Front Door, Molding - Scratch & Dent - Minimal / (L) Front Fender, Molding - Scratch - Minimal / Front Bumper, Grille, Lamps - Scratch & Dent - Medium / Bonnet, Headlight - Scratch - Minimal</p>

With Lto plate, with warranty booklet, with spare tire and jack, 1key, no tools, scratches on headlights and taillights,
