General Information

Make	Toyota	Model	Vios
YOM	2025	Odo Meter Reading	14,719
Registration No.	NJA7899	Chassis No.	PA1B18F30S4285742
CC	1.3	Transmission	CVT
Fuel Type	Gas	Type of Body	Sedan
Colour	Blue

Body / Panel Condition

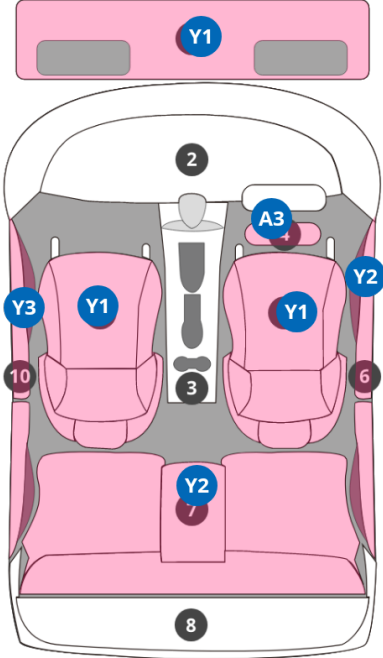
Interior Evaluation : B	Exterior Evaluation : D

<p>a : Cut, Fray d : Loose, Deformed k : Animal Hair s : Smell t : Cigarette Burns x : Defective y : Stain</p>

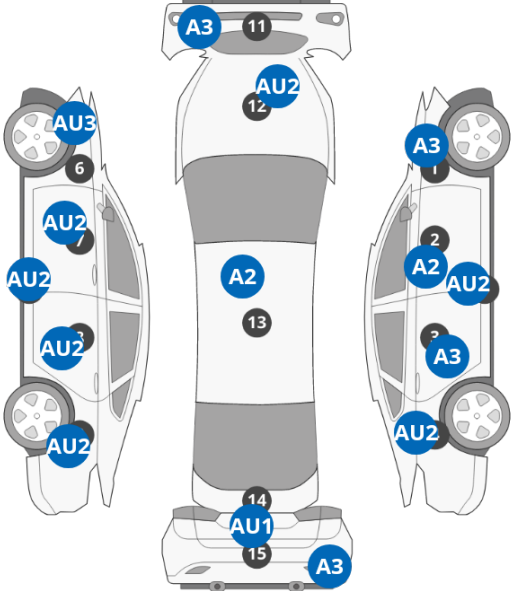
<p>A : Scratch AU : Scratch & Dent B : Modified C : Corrosion G : Stone chip P : Faded S : Rust SC : Rust & Corrosion U : Dent X : Defective Y : Crack, Gap</p>
<p>Remarks (L) Front Floor Mat - Cut, Crack - Medium / (L) Front Trim - Grime - Medium / (R) Front Trim - Grime - Small / (L) Front Seat - Grime - Minimal / (R) Front Seat - Grime - Minimal / Rear Seat - Grime - Small / Ceiling - Grime - Minimal</p>	<p>Remarks Roof - Scratch - Small / (L) Front Fender, Molding - Scratch & Dent - Medium / (R) Front Fender, Molding - Scratch - Medium / Bonnet, Headlight - Scratch & Dent - Small / Front Bumper, Grille, Lamps - Scratch - Medium / (L) Front Door, Molding - Scratch & Dent - Small / (L) Rear Door, Molding - Scratch & Dent - Small / (L) Rear Fender, Molding - Scratch & Dent - Small / Trunk Hood, Rear Gate - Scratch & Dent - Minimal / Rear Bumper, Lamps, Panels - Scratch - Medium / (R) Rear Fender, Molding - Scratch & Dent - Small / (R) Rear Door, Molding - Scratch - Medium / (R) Front Door, Molding - Scratch - Small / (R) Step, In-panel, Side Spoiler - Scratch & Dent - Small</p>
