General Information

Make	Toyota	Model	Vios
YOM	2024	Odo Meter Reading	31,371
Registration No.	DBN4616	Chassis No.	PA1B18F31P4232376
CC	1.3	Transmission	CVT
Fuel Type	Gas	Type of Body	Sedan
Colour	Green

Body / Panel Condition

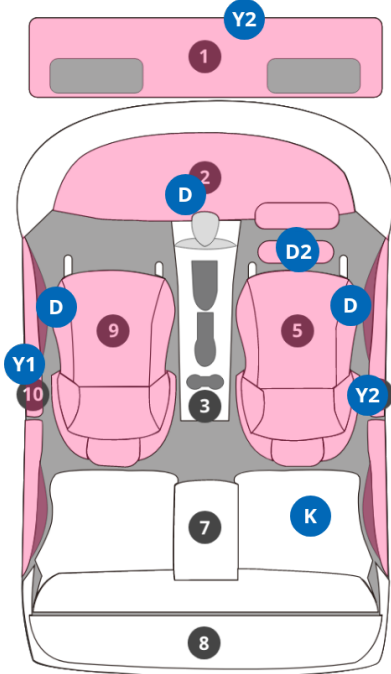
Interior Evaluation : C	Exterior Evaluation : D

<p>a : Cut, Fray d : Loose, Deformed k : Animal Hair s : Smell t : Cigarette Burns x : Defective y : Stain</p>

<p>A : Scratch AU : Scratch & Dent B : Modified C : Corrosion G : Stone chip P : Faded S : Rust SC : Rust & Corrosion U : Dent X : Defective Y : Crack, Gap</p>
<p>Remarks Dashboard - Traces of Adhesive Tape - Yes / Ceiling - Grime - Small / Overall Interior - Animal Hair - Yes / (R) Front Trim - Grime - Small / (L) Front Trim - Grime - Minimal / (R) Front Floor Mat - Worked - Small / (L) Front Floor Mat - Worked - Small / (R) Front Seat - Worn - Yes / (L) Front Seat - Worn - Yes</p>	<p>Remarks (R) Rear Door, Molding - Scratch & Dent - Large / (R) Front Door, Molding - Scratch & Dent - Medium / (R) Front Fender, Molding - Scratch - Small / (R) Mirror - Scratch - Minimal / (R) Rear Fender, Molding - Scratch - Minimal / Rear Bumper, Lamps, Panels - Scratch - Large / Trunk Hood, Rear Gate - Dent - Minimal / (L) Rear Door, Molding - Scratch - Minimal / (L) Rear Fender, Molding - Scratch - Minimal / (L) Front Door, Molding - Scratch - Small / (L) Mirror - Scratch - Minimal / (R) Step, In-panel, Side Spoiler - Scratch & Dent - Small / (L) Front Fender, Molding - Scratch - Small / Front Bumper, Grille, Lamps - Scratch & Dent - Medium / Bonnet, Headlight - Scratch - Minimal / Roof - Scratch - Small</p>

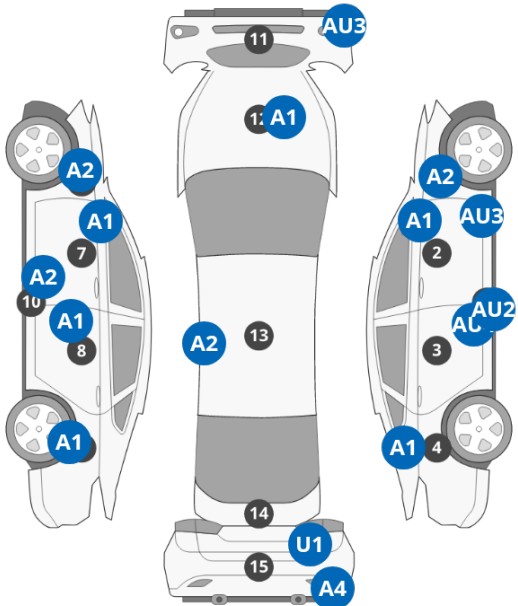
<p>Inspector Notes</p>
<p>with warranty booklet, jack and tools, with spare tire, with LTO plate, scratches on tail light, possible flooding</p>
