General Information

Make	Toyota	Model	Vios
YOM	2025	Odo Meter Reading	32,333
Registration No.	DBP8768	Chassis No.	PA1B18F35R4266811
CC	1.3	Transmission	CVT
Fuel Type	Gas	Type of Body	Sedan
Colour	Blue

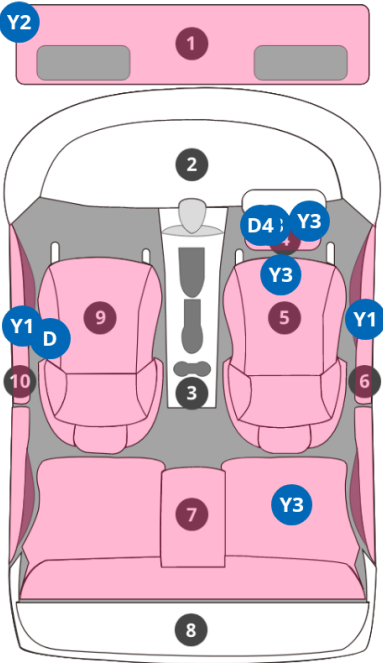
Interior Evaluation : C	Exterior Evaluation : D

<p>a : Cut, Fray d : Loose, Deformed k : Animal Hair s : Smell t : Cigarette Burns x : Defective y : Stain</p>

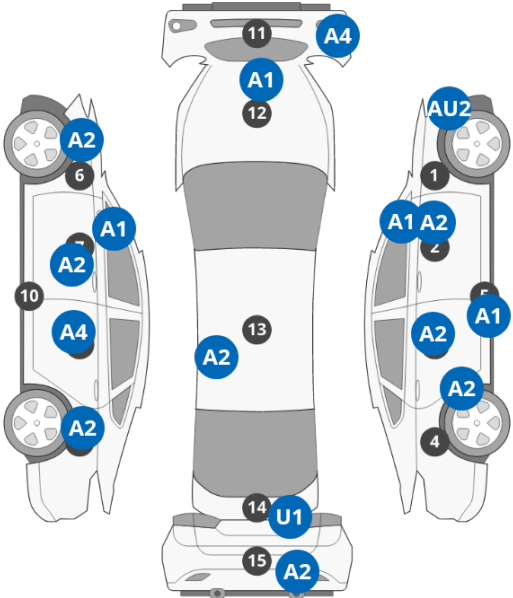
<p>A : Scratch AU : Scratch & Dent B : Modified C : Corrosion G : Stone chip P : Faded S : Rust SC : Rust & Corrosion U : Dent X : Defective Y : Crack, Gap</p>
<p>Remarks (R) Front Seat - Grime - Medium / Rear Seat - Grime - Medium / (L) Front Seat - Worn - Yes / (L) Front Floor Mat - Cut, Crack - Medium / (L) Front Floor Mat - Worked - Large / (R) Front Trim - Grime - Minimal / (L) Front Trim - Grime - Minimal / (R) Front Floor Mat - Grime - Medium / Ceiling - Grime - Small</p>	<p>Remarks (R) Front Fender, Molding - Scratch & Dent - Small / (R) Mirror - Scratch - Minimal / (R) Rear Door, Molding - Scratch - Small / (R) Step, In-panel, Side Spoiler - Scratch - Minimal / (R) Front Door, Molding - Scratch - Small / (R) Rear Fender, Molding - Scratch - Small / Rear Bumper, Lamps, Panels - Scratch - Small / Trunk Hood, Rear Gate - Dent - Minimal / (L) Rear Fender, Molding - Scratch - Small / (L) Front Door, Molding - Scratch - Small / (L) Rear Door, Molding - Scratch - Large / (L) Mirror - Scratch - Minimal / (L) Front Fender, Molding - Scratch - Small / Front Bumper, Grille, Lamps - Scratch - Large / Bonnet, Headlight - Scratch - Minimal / Roof - Scratch - Small</p>

<p>Inspector Notes</p>
<p>no warranty booklet, with jack and tools, no spare tire, with LTO plate, scratches on tail light</p>
