General Information

Make	Toyota	Model	Fortuner
YOM	2025	Odo Meter Reading	15,006
Registration No.	DBT3438	Chassis No.	MHFCB3GS7R0498182
CC	2.4	Transmission	A/T
Fuel Type	Diesel	Type of Body	Wagon
Colour	White

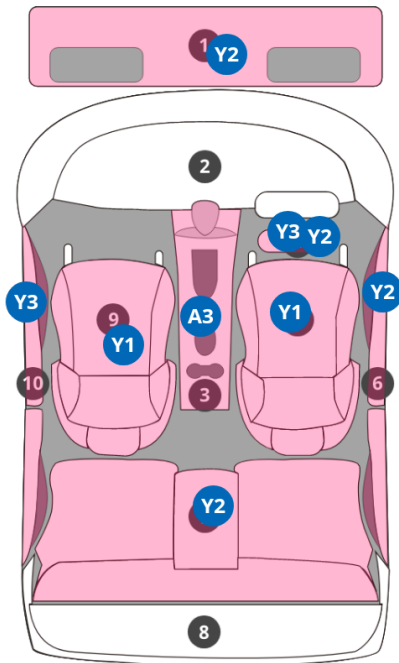
Interior Evaluation : C	Exterior Evaluation : C

<p>a : Cut, Fray d : Loose, Deformed k : Animal Hair s : Smell t : Cigarette Burns x : Defective y : Stain</p>

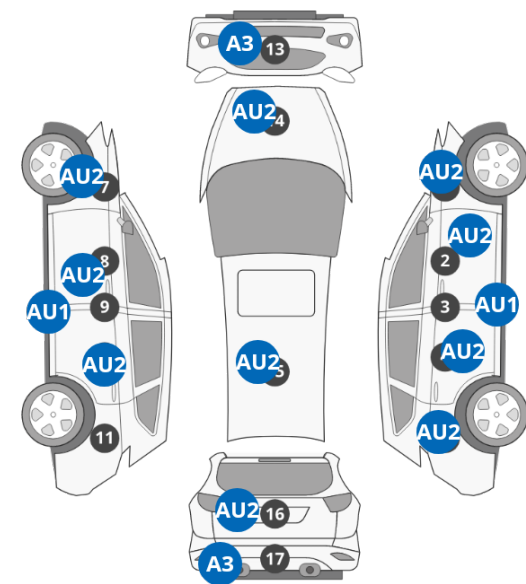
<p>A : Scratch AU : Scratch & Dent B : Modified C : Corrosion G : Stone chip P : Faded S : Rust SC : Rust & Corrosion U : Dent X : Defective Y : Crack, Gap</p>
<p>Remarks (L) Front Trim - Grime - Medium / (L) Front Floor Mat - Grime - Medium / (R) Front Floor Mat - Grime - Small / (L) Front Seat - Grime - Minimal / (R) Front Seat - Grime - Minimal / (R) Front Trim - Grime - Small / Rear Seat - Grime - Small / Ceiling - Grime - Small / Console, Switchs, Vents - Worn, Scratch, Cut, Crack - Medium</p>	<p>Remarks (L) Rear Door, Molding - Scratch & Dent - Small / (L) Front Door, Molding - Scratch & Dent - Small / (L) Front Fender, Molding - Scratch & Dent - Small / Bonnet, Headlight - Scratch & Dent - Small / Front Bumper, Grille, Lamps - Scratch - Medium / (R) Front Fender, Molding - Scratch & Dent - Small / (R) Front Door, Molding - Scratch & Dent - Small / (R) Rear Door, Molding - Scratch & Dent - Small / (R) Rear Fender, Molding - Scratch & Dent - Small / Rear Bumper, Lamps, Panels - Scratch - Medium / Roof - Scratch & Dent - Small / Trunk Hood, Rear Gate - Scratch & Dent - Small / (L) Step, In-panel, Side Spoiler - Scratch & Dent - Minimal / (R) Step, In-panel, Side Spoiler - Scratch & Dent - Minimal</p>
