General Information

Make	Toyota	Model	Vios
YOM	2024	Odo Meter Reading	45,603
Registration No.	NKD8970-1	Chassis No.	PA1B18F30R4258311
CC	1.3	Transmission	CVT
Fuel Type	Gas	Type of Body	Sedan
Colour	Red

Body / Panel Condition

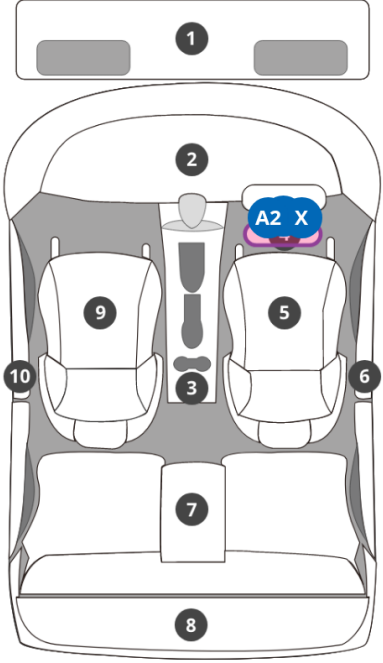
Interior Evaluation : B	Exterior Evaluation : C

<p>a : Cut, Fray d : Loose, Deformed k : Animal Hair s : Smell t : Cigarette Burns x : Defective y : Stain</p>

<p>A : Scratch AU : Scratch & Dent B : Modified C : Corrosion G : Stone chip P : Faded S : Rust SC : Rust & Corrosion U : Dent X : Defective Y : Crack, Gap</p>
Remarks (R) Front Floor Mat - Missing - Yes / Mat Other - Missing - Yes / (L) Front Floor Mat - Cut, Crack - Small	Remarks (R) Front Fender - Repair Traces - Yes / (L) Front Fender - Repair Traces - Yes / (R) Front Fender, Molding - Repair mark - Yes / (R) Front Fender, Molding - Scratch - Minimal / (R) Mirror - Scratch - Minimal / (R) Step, In-panel, Side Spoiler - Scratch - Medium / (R) Rear Door, Molding - Scratch & Dent - Minimal / (R) Front Door, Molding - Scratch - Small / (R) Rear Fender, Molding - Scratch - Minimal / Rear Bumper, Lamps, Panels - Crack, Gap - Small / Trunk Hood, Rear Gate - Scratch - Minimal / (L) Rear Fender, Molding - Scratch - Minimal / (L) Rear Door, Molding - Scratch - Minimal / (L) Step, In-panel, Side Spoiler - Scratch - Minimal / (L) Front Door, Molding - Scratch - Minimal / (L) Mirror - Scratch - Minimal / (L) Front Fender, Molding - Repair mark - Yes / (L) Front Fender, Molding - Scratch - Minimal / Bonnet, Headlight - Scratch - Minimal / Front Bumper, Grille, Lamps - Repair mark - Yes / Front Bumper, Grille, Lamps - Scratch & Dent - Medium

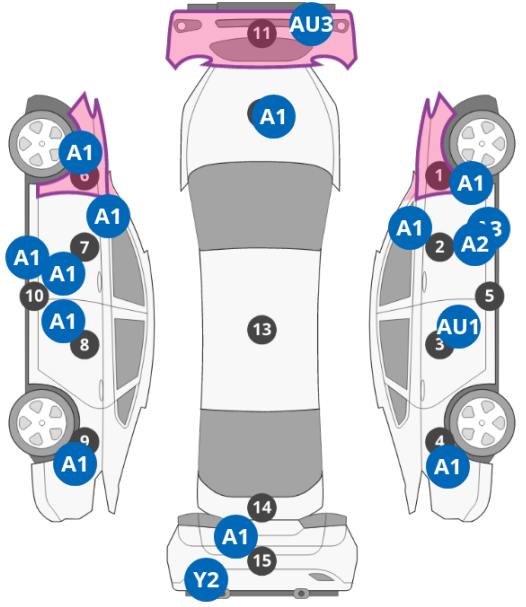
Inspector Notes
With Lto plate,1key, no warranty booklet, no spare tire, no jack and tools, scratches on headlights and taillights, battery weak
