General Information

Make	Toyota	Model	Vios
YOM	2022	Odo Meter Reading	34,849
Registration No.	NGX2546-1	Chassis No.	PA1B18F38N4170049
CC	1.3	Transmission	CVT
Fuel Type	Gas	Type of Body	Sedan
Colour	Blue

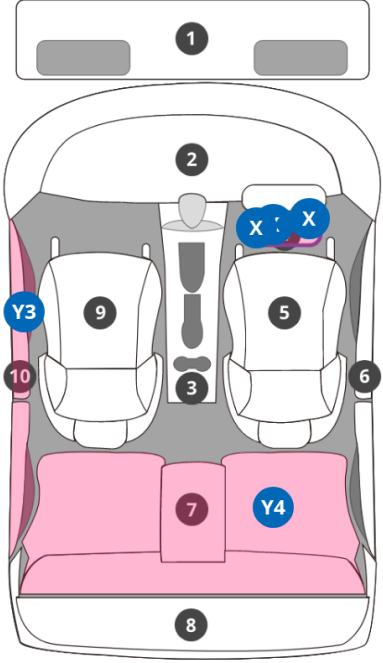
Interior Evaluation : C	Exterior Evaluation : E

<p>a : Cut, Fray d : Loose, Deformed k : Animal Hair s : Smell t : Cigarette Burns x : Defective y : Stain</p>

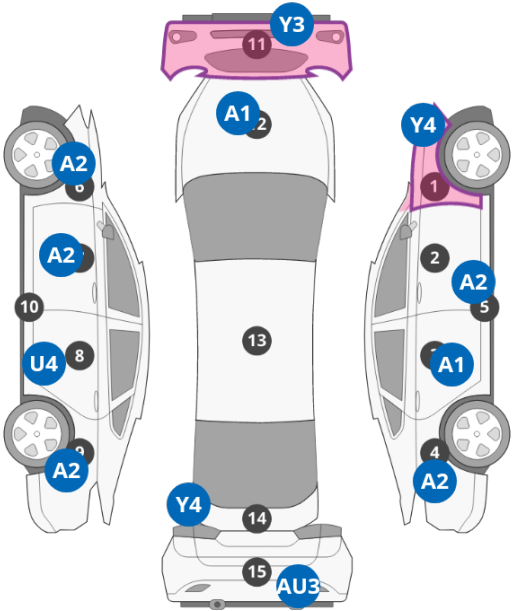
<p>A : Scratch AU : Scratch & Dent B : Modified C : Corrosion G : Stone chip P : Faded S : Rust SC : Rust & Corrosion U : Dent X : Defective Y : Crack, Gap</p>
<p>Remarks Rear Seat - Grime - Large / (L) Front Trim - Grime - Medium / (L) Front Floor Mat - Missing - Yes / (R) Front Floor Mat - Missing - Yes / Mat Other - Missing - Yes</p>	<p>Remarks (L) Rear Door, Molding - Dent - Large / (R) Front Fender, Molding - Repair mark - Yes / Trunk Hood, Rear Gate - Crack, Gap - Large / Rear Bumper, Lamps, Panels - Scratch & Dent - Medium / Front Bumper, Grille, Lamps - Repair mark - Yes / Front Bumper, Grille, Lamps - Crack, Gap - Medium / (R) Front Fender, Molding - Crack, Gap - Large / (L) Front Door, Molding - Scratch - Small / (L) Front Fender, Molding - Scratch - Small / (L) Rear Fender, Molding - Scratch - Small / (R) Rear Fender, Molding - Scratch - Small / (R) Rear Door, Molding - Scratch - Minimal / (R) Front Door, Molding - Scratch - Small / Bonnet, Headlight - Scratch - Minimal</p>
