General Information

Body / Panel Condition

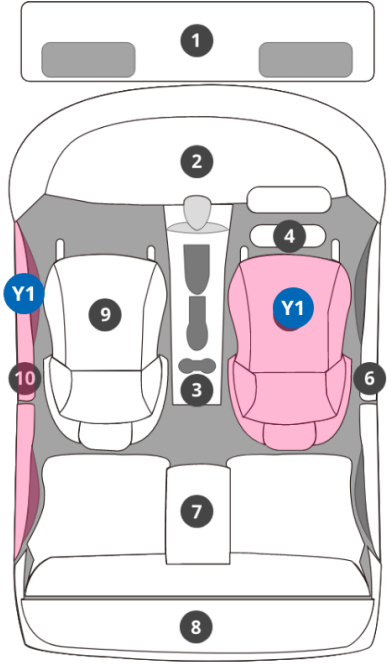
<p>a : Cut, Fray d : Loose, Deformed k : Animal Hair s : Smell t : Cigarette Burns x : Defective y : Stain</p>

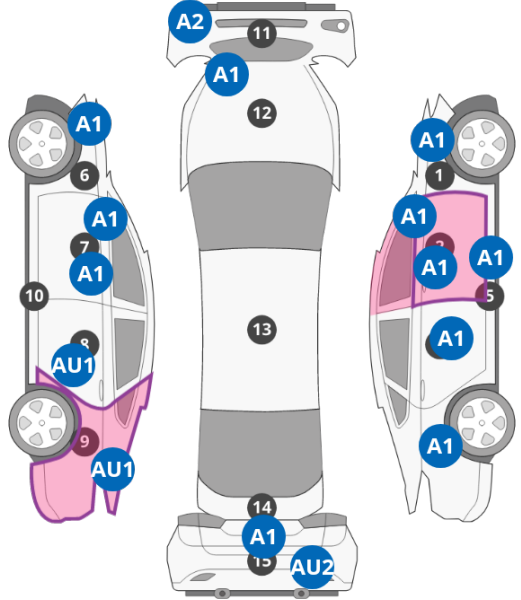
<p>A : Scratch AU : Scratch & Dent B : Modified C : Corrosion G : Stone chip P : Faded S : Rust SC : Rust & Corrosion U : Dent X : Defective Y : Crack, Gap</p>
<p>Remarks (R) Front Seat - Grime - Minimal / (L) Front Trim - Grime - Minimal</p>	<p>Remarks (R) Front Door - Repair Traces - Yes / (L) Rear Fender - Repair Traces - Yes / (R) Front Fender, Molding - Scratch - Minimal / (R) Mirror - Scratch - Minimal / (R) Step, In-panel, Side Spoiler - Scratch - Minimal / (R) Front Door, Molding - Repair mark - Yes / (R) Front Door, Molding - Scratch - Minimal / (R) Rear Door, Molding - Scratch - Minimal / Rear Bumper, Lamps, Panels - Scratch & Dent - Small / Trunk Hood, Rear Gate - Scratch - Minimal / (L) Mirror - Scratch - Minimal / (L) Rear Door, Molding - Scratch & Dent - Minimal / (L) Front Door, Molding - Scratch - Minimal / (L) Front Fender, Molding - Scratch - Minimal / Bonnet, Headlight - Scratch - Minimal / Front Bumper, Grille, Lamps - Scratch - Small / (R) Rear Fender, Molding - Scratch - Minimal / (L) Rear Fender, Molding - Repair mark - Yes / (L) Rear Fender, Molding - Scratch & Dent - Minimal</p>
