General Information

Make	Toyota	Model	Rush
YOM	2019	Odo Meter Reading	78,849
Registration No.	NDO9387	Chassis No.	MHKE8FF3PKK008116
CC	1.5	Transmission	A/T
Fuel Type	Gas	Type of Body	SUV
Colour	Red

Body / Panel Condition

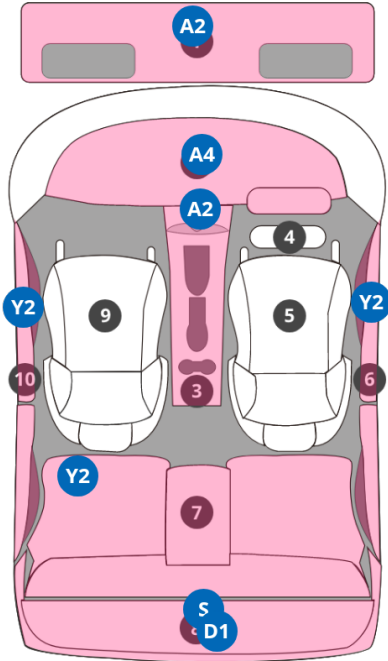
Interior Evaluation : C	Exterior Evaluation : D

<p>a : Cut, Fray d : Loose, Deformed k : Animal Hair s : Smell t : Cigarette Burns x : Defective y : Stain</p>

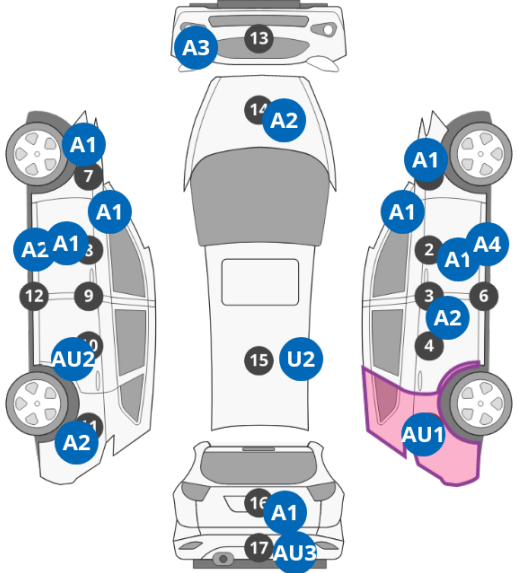
<p>A : Scratch AU : Scratch & Dent B : Modified C : Corrosion G : Stone chip P : Faded S : Rust SC : Rust & Corrosion U : Dent X : Defective Y : Crack, Gap</p>
<p>Remarks Ceiling - Cut, Crack - Small / (L) Front Trim - Grime - Small / (R) Front Trim - Grime - Small / Steering Wheel - Worn, Peel, Crack - Large / Knobs - Worn, Peel, Crack - Small / Overall Interior - Smell - Yes / Rear Seat - Grime - Small / Trunk Room - Worked - Minimal</p>	<p>Remarks (R) Front Door - Repair Traces - Yes / (R) Front Fender - Repair Traces - Yes / Bonnet - Repair Traces - Yes / (L) Front Fender - Repair Traces - Yes / (L) Front Door - Repair Traces - Yes / (L) Rear Door - Repair Traces - Yes / (L) Rear Fender - Repair Traces - Yes / Trunk Hood, Rear Gate - Repair Traces - Yes / (R) Rear Fender - Repair Traces - Yes / (R) Rear Door - Repair Traces - Yes / Roof - Repair Traces - Yes / (R) Front Fender, Molding - Scratch - Minimal / (R) Mirror - Scratch - Minimal / (R) Front Door, Molding - Scratch - Minimal / (R) Step, In-panel, Side Spoiler - Scratch - Large / (R) Rear Door, Molding - Scratch - Small / Overall Exterior - Full Re-Paint in same color - Yes / (R) Rear Fender, Molding - Repair mark - Difference in Color / Roof - Dent - Small / (R) Rear Fender, Molding - Scratch & Dent - Minimal / Rear Bumper, Lamps, Panels - Scratch & Dent - Medium / Trunk Hood, Rear Gate - Scratch - Minimal / (L) Rear Fender, Molding - Scratch - Small / (L) Rear Door, Molding - Scratch & Dent - Small / (L) Step, In-panel, Side Spoiler - Scratch - Small / (L) Front Door, Molding - Scratch - Minimal / (L) Mirror - Scratch - Minimal / (L) Front Fender, Molding - Scratch - Minimal / Front Bumper, Grille, Lamps - Scratch - Medium / Bonnet, Headlight - Scratch - Small</p>
