General Information

Make	Mitsubishi	Model	Montero SPT
YOM	2017	Odo Meter Reading	75,365
Registration No.	NCN6540	Chassis No.	MMBGUKR13P00626326
CC	2.4	Transmission	A/T
Fuel Type	Diesel	Type of Body	SUV
Colour	Blue

Body / Panel Condition

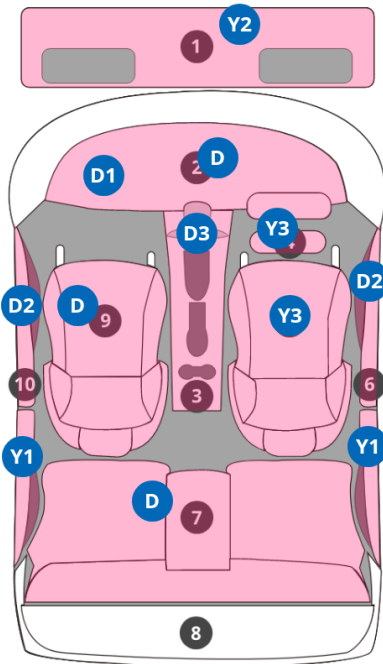
Interior Evaluation : C	Exterior Evaluation : E

<p>a : Cut, Fray d : Loose, Deformed k : Animal Hair s : Smell t : Cigarette Burns x : Defective y : Stain</p>

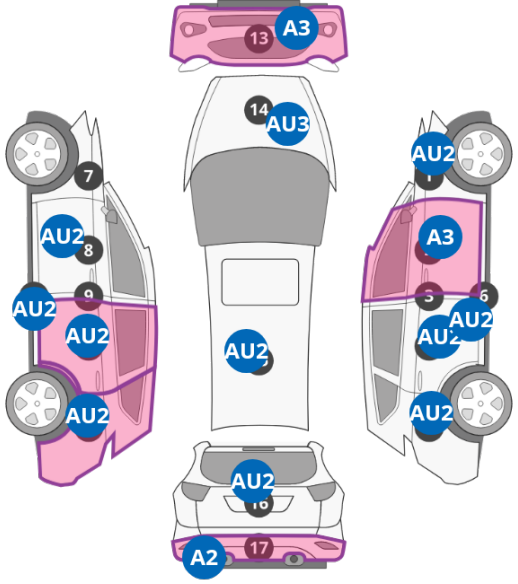
<p>A : Scratch AU : Scratch & Dent B : Modified C : Corrosion G : Stone chip P : Faded S : Rust SC : Rust & Corrosion U : Dent X : Defective Y : Crack, Gap</p>
<p>Remarks (L) Front Floor Mat - Grime - Medium / (L) Front Trim - Worked - Small / (L) Front Seat - Worn - Yes / (R) Front Seat - Grime - Medium / Console, Switches, Vents - Loose, Deformed - Medium / Ceiling - Grime - Small / Rear Seat - Worn - Yes / (R) Front Trim - Worked - Small / (R) Rear Trim - Grime - Minimal / (L) Rear Trim - Grime - Minimal / Dashboard - Worked - Minimal / Instrument Panel - Traces of Adhesive Tape - Yes</p>	<p>Remarks (R) Front Door - Repair Traces - Yes / (R) Front Fender - Repair Traces - Yes / Bonnet - Repair Traces - Yes / (L) Front Fender - Repair Traces - Yes / (L) Front Door - Repair Traces - Yes / (L) Rear Door - Repair Traces - Yes / (L) Rear Fender - Repair Traces - Yes / Trunk Hood, Rear Gate - Repair Traces - Yes / (R) Rear Fender - Repair Traces - Yes / (R) Rear Door - Repair Traces - Yes / Roof - Repair Traces - Yes / Overall Exterior - Full Re-Paint in same color - Yes / Trunk Hood, Rear Gate - Scratch & Dent - Small / Rear Bumper, Lamps, Panels - Scratch - Small / Rear Bumper, Lamps, Panels - Repair mark - Yes / (L) Rear Fender, Molding - Scratch & Dent - Small / (L) Rear Fender, Molding - Repair mark - Yes / (L) Rear Door, Molding - Scratch & Dent - Small / (L) Rear Door, Molding - Repair mark - Yes / (L) Front Door, Molding - Scratch & Dent - Small / Roof - Scratch & Dent - Small / Bonnet, Headlight - Scratch & Dent - Medium / Front Bumper, Grille, Lamps - Repair mark - Yes / Front Bumper, Grille, Lamps - Scratch - Medium / (R) Front Fender, Molding - Scratch & Dent - Small / (R) Front Door, Molding - Scratch - Medium / (R) Front Door, Molding - Repair mark - Yes / (R) Rear Door, Molding - Scratch & Dent - Small / (R) Step, In-panel, Side Spoiler - Scratch & Dent - Small / (L) Step, In-panel, Side Spoiler - Scratch & Dent - Small / (R) Rear Fender, Molding - Scratch & Dent - Small</p>
