General Information

Make	Toyota	Model	Vios
YOM	2021	Odo Meter Reading	171,596
Registration No.	NGP9560	Chassis No.	PA1B18F35L4128239
CC	1.3	Transmission	CVT
Fuel Type	Gas	Type of Body	Sedan
Colour	Blackish Red Mica

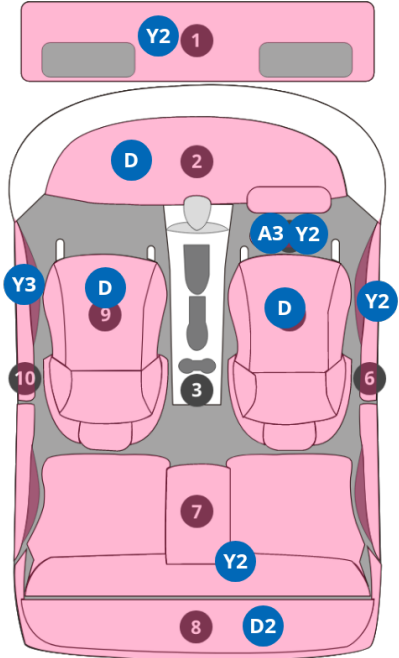
Interior Evaluation : C	Exterior Evaluation : E

<p>a : Cut, Fray d : Loose, Deformed k : Animal Hair s : Smell t : Cigarette Burns x : Defective y : Stain</p>

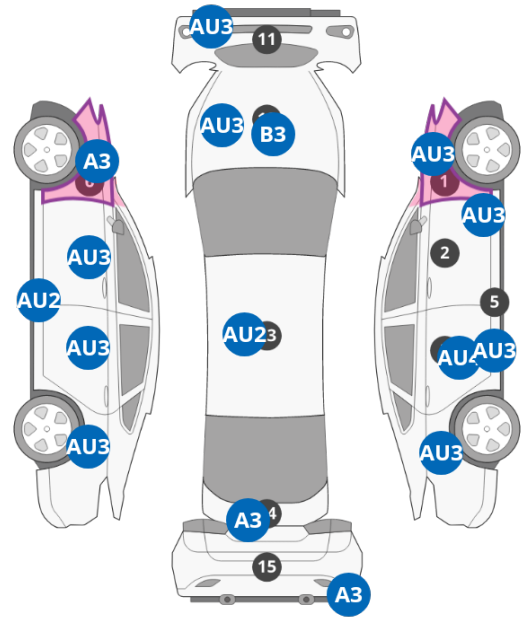
<p>A : Scratch AU : Scratch & Dent B : Modified C : Corrosion G : Stone chip P : Faded S : Rust SC : Rust & Corrosion U : Dent X : Defective Y : Crack, Gap</p>
Remarks (L) Front Floor Mat - Cut, Crack - Medium / (L) Front Trim - Grime - Medium / (L) Front Seat - Worn - Yes / (R) Front Seat - Worn - Yes / (R) Front Floor Mat - Grime - Small / Rear Seat - Grime - Small / Dashboard - Traces of Adhesive Tape - Yes / Ceiling - Grime - Small / (R) Front Trim - Grime - Small / Trunk Room - Loose, Deformed - Small	Remarks (L) Rear Fender, Molding - Scratch & Dent - Medium / (L) Front Fender, Molding - Repair mark - Yes / Trunk Hood, Rear Gate - Scratch - Medium / Rear Bumper, Lamps, Panels - Scratch - Medium / (R) Rear Fender, Molding - Scratch & Dent - Medium / (R) Rear Door, Molding - Scratch & Dent - Large / (R) Step, In-panel, Side Spoiler - Scratch & Dent - Medium / (R) Front Door, Molding - Scratch & Dent - Medium / (R) Front Fender, Molding - Scratch & Dent - Medium / (R) Front Fender, Molding - Repair mark - Yes / Roof - Scratch & Dent - Small / Bonnet, Headlight - Scratch & Dent - Medium / Bonnet, Headlight - Modified - Medium / Front Bumper, Grille, Lamps - Scratch & Dent - Medium / (L) Front Fender, Molding - Scratch - Medium / (L) Front Door, Molding - Scratch & Dent - Medium / (L) Step, In-panel, Side Spoiler - Scratch & Dent - Small / (L) Rear Door, Molding - Scratch & Dent - Medium
