General Information

Make	Geely	Model	Coolray
YOM	2022	Odo Meter Reading	50,069
Registration No.	DBF4934	Chassis No.	LB37622ZXMX414961
CC	1.5	Transmission	A/T
Fuel Type	Gas	Type of Body	SUV
Colour	Red

Body / Panel Condition

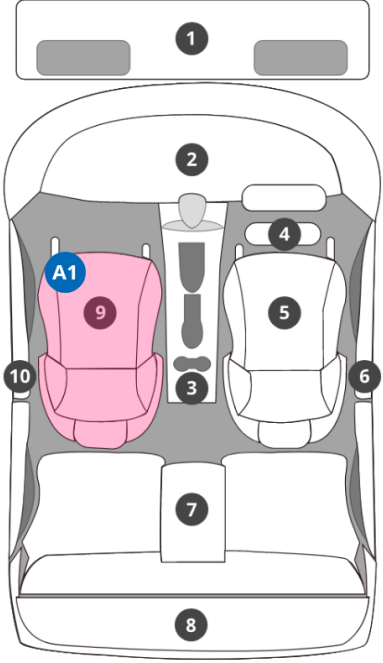
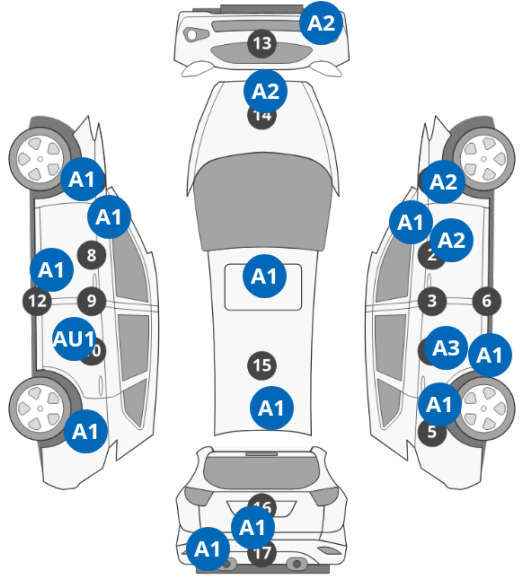
Interior Evaluation :	A	Exterior Evaluation :	C

<p>a : Cut, Fray d : Loose, Deformed k : Animal Hair s : Smell t : Cigarette Burns x : Defective y : Stain</p>		<p>A : Scratch AU : Scratch & Dent B : Modified C : Corrosion G : Stone chip P : Faded S : Rust SC : Rust & Corrosion U : Dent X : Defective Y : Crack, Gap</p>	
<p>Remarks (L) Front Seat - Cut, Crack - Minimal</p>		<p>Remarks Roof - Repair Traces - Yes / (R) Front Fender, Molding - Scratch - Small / (R) Mirror - Scratch - Minimal / (R) Front Door, Molding - Scratch - Small / (R) Rear Door, Molding - Scratch - Medium / (R) Step, In-panel, Side Spoiler - Scratch - Minimal / (R) Rear Fender, Molding - Scratch - Minimal / Roof - Scratch - Minimal / Rear Bumper, Lamps, Panels - Scratch - Minimal / Roof Spoiler, Molding - Scratch - Minimal / Trunk Hood, Rear Gate - Scratch - Minimal / (L) Rear Fender, Molding - Scratch - Minimal / (L) Rear Door, Molding - Scratch & Dent - Minimal / (L) Front Door, Molding - Scratch - Minimal / (L) Mirror - Scratch - Minimal / (L) Front Fender, Molding - Scratch - Minimal / Bonnet, Headlight - Scratch - Small / Front Bumper, Grille, Lamps - Scratch - Small</p>

Inspector Notes
With Lto plate, with spare tire and jack, 2keys, no warranty booklet and tools, scratches on headlights and taillights
