General Information

Make	Toyota	Model	Hilux Tamaraw
YOM	2025	Odo Meter Reading	21,043
Registration No.	NKT8037	Chassis No.	PAHACACA3S6424154
CC	2.4	Transmission	M/T
Fuel Type	Diesel	Type of Body	Utility Passenger
Colour	White

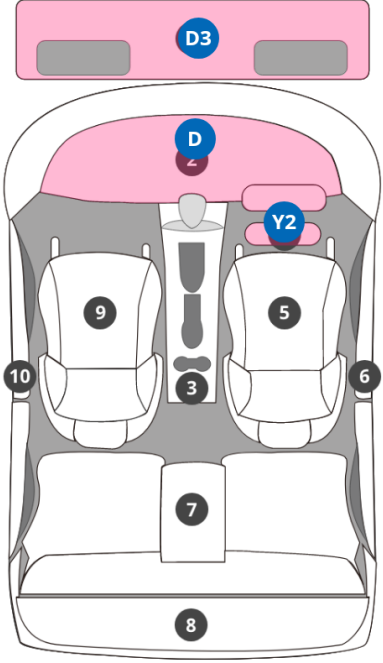
<p>a : Cut, Fray d : Loose, Deformed k : Animal Hair s : Smell t : Cigarette Burns x : Defective y : Stain</p>

<p>A : Scratch AU : Scratch & Dent B : Modified C : Corrosion G : Stone chip P : Faded S : Rust SC : Rust & Corrosion U : Dent X : Defective Y : Crack, Gap</p>
<p>Remarks Ceiling - Loose, Deformed - Medium / Dashboard - Traces of Adhesive Tape - Yes / (L) Front Floor Mat - Grime - Small</p>	<p>Remarks (R) Front Fender, Molding - Scratch & Dent - Medium / (R) Front Door, Molding - Scratch & Dent - Medium / (R) Step, In-panel, Side Spoiler - Scratch - Medium / (R) Side Gate - Scratch & Dent - Large / Rear Bumper, Lamps, Panels - Scratch - Small / Roof - Scratch & Dent - Small / Rear Gate - Scratch - Minimal / (L) Side Gate - Partially Missing - Yes / (L) Front Door, Molding - Scratch & Dent - Medium / (L) Front Fender, Molding - Scratch - Minimal / Bonnet, Headlight - Scratch - Minimal / Front Bumper, Grille, Lamps - Scratch - Small / (L) Mirror - Scratch - Minimal / (R) Mirror - Scratch - Minimal</p>
