## General Information

| Make | Toyota | Model | Hilux |

## Body / Panel Condition

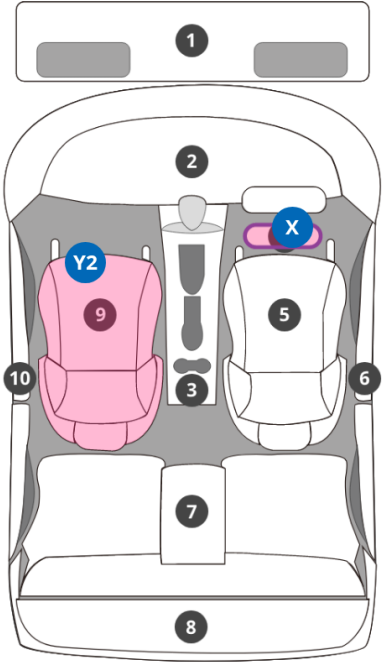
| Interior Evaluation : <b>B</b> | Exterior Evaluation : <b>C</b> |
|---|---|
| <p><b>Remarks</b><br/>Mat Other - Missing - Yes / (L) Front Seat - Grime - Small</p> | <p><b>Remarks</b><br/>Bonnet - Repair Traces - Yes / (L) Rear Door, Molding - Scratch - Medium / (L) Front Fender, Molding - Scratch - Small / (R) Front Door, Molding - Dent - Small / (L) Rear Wheel, Cover - Scratch, Corrosion - Small / Roof - Scratch &amp; Dent - Medium / Rear Gate - Dent - Small / Rear Bumper, Lamps, Panels - Scratch - Medium</p> |
