General Information

Make	Toyota	Model	Hilux
YOM	2025	Odo Meter Reading	10,478
Registration No.	NKN6539	Chassis No.	MR0JB8DD0R3236106
CC	2.4	Transmission	A/T
Fuel Type	Diesel	Type of Body	Pickup
Colour	Black

Body / Panel Condition

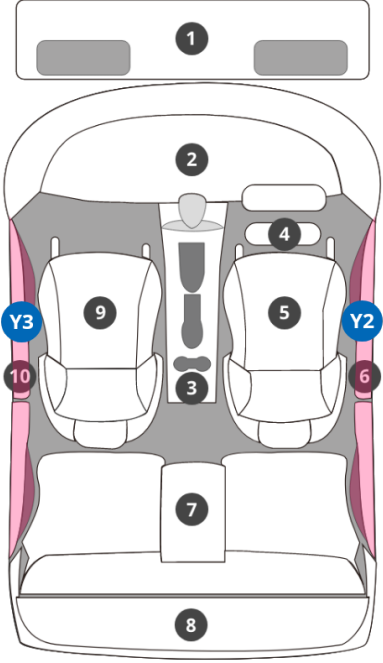
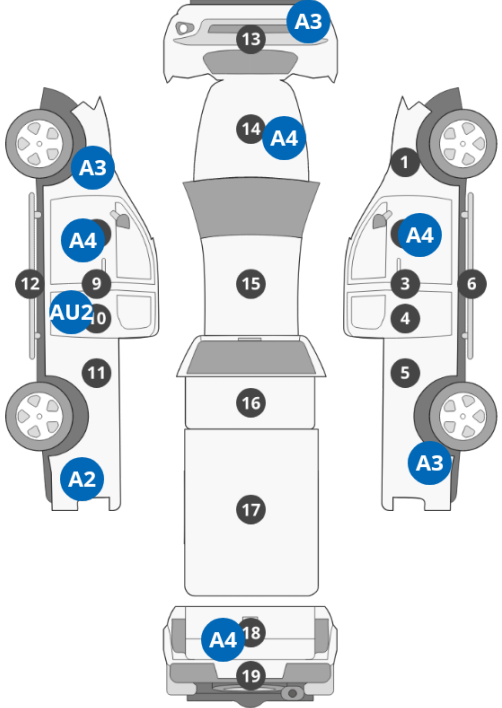
Interior Evaluation :	B	Exterior Evaluation :	E

<p>a : Cut, Fray d : Loose, Deformed k : Animal Hair s : Smell t : Cigarette Burns x : Defective y : Stain</p>		<p>A : Scratch AU : Scratch & Dent B : Modified C : Corrosion G : Stone chip P : Faded S : Rust SC : Rust & Corrosion U : Dent X : Defective Y : Crack, Gap</p>	
<p>Remarks (R) Front Trim - Grime - Small / (L) Front Trim - Grime - Medium</p>		<p>Remarks Bonnet, Headlight - Scratch - Large / Front Bumper, Grille, Lamps - Scratch - Medium / (R) Front Door, Molding - Scratch - Large / (R) Side Gate - Scratch - Medium / Rear Gate - Scratch - Large / (L) Side Gate - Scratch - Small / (L) Rear Door, Molding - Scratch & Dent - Small / (L) Front Door, Molding - Scratch - Large / (L) Front Fender, Molding - Scratch - Medium</p>	
Frame Evaluation :	A	Functional Evaluation :	A
<p>Remarks Defects not found</p>		<p>Remarks Defects not found</p>
