General Information

Make	Toyota	Model	Hilux
YOM	2023	Odo Meter Reading	50,297
Registration No.	NHJ7202	Chassis No.	MR0AB8DDXP5147970
CC	2.4	Transmission	A/T
Fuel Type	Diesel	Type of Body	Pickup
Colour	Red

Body / Panel Condition

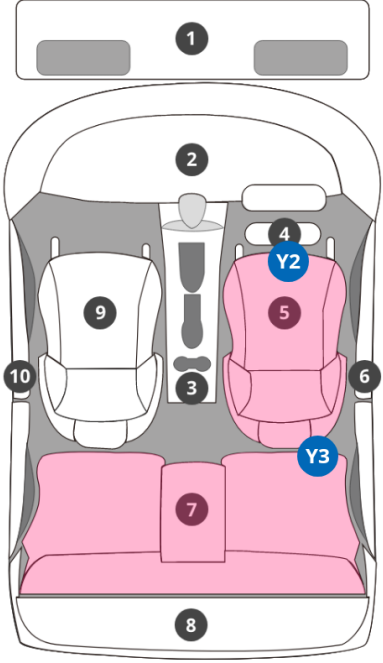
Interior Evaluation : B	Exterior Evaluation : E

<p>a : Cut, Fray d : Loose, Deformed k : Animal Hair s : Smell t : Cigarette Burns x : Defective y : Stain</p>

<p>A : Scratch AU : Scratch & Dent B : Modified C : Corrosion G : Stone chip P : Faded S : Rust SC : Rust & Corrosion U : Dent X : Defective Y : Crack, Gap</p>
<p>Remarks Rear Seat - Grime - Medium / (R) Front Seat - Grime - Small</p>	<p>Remarks (R) Step - Repair Traces - Yes / (L) Step - Repair Traces - Yes / (R) Rear Door - Repair Traces - Yes / Rear Gate - Repair mark - Yes / (L) Rear Door, Molding - Scratch & Dent - Large / (L) Front Door, Molding - Scratch & Dent - Medium / (L) Front Fender, Molding - Scratch - Large / Front Bumper, Grille, Lamps - Scratch - Large / Bonnet, Headlight - Scratch - Large / (R) Front Fender, Molding - Scratch - Small / (R) Front Door, Molding - Scratch & Dent - Medium / (R) Rear Door, Molding - Scratch - Large / Rear Bumper, Lamps, Panels - Crack, Gap - Medium / (L) Side Gate - Scratch - Medium / (R) Side Gate - Scratch - Small</p>
