General Information

Make	Toyota	Model	Vios
YOM	2025	Odo Meter Reading	33,144
Registration No.	NIO8088	Chassis No.	PA1B18F35S4284957
CC	1.3	Transmission	CVT
Fuel Type	Gas	Type of Body	Sedan
Colour	Blackish Red Mica

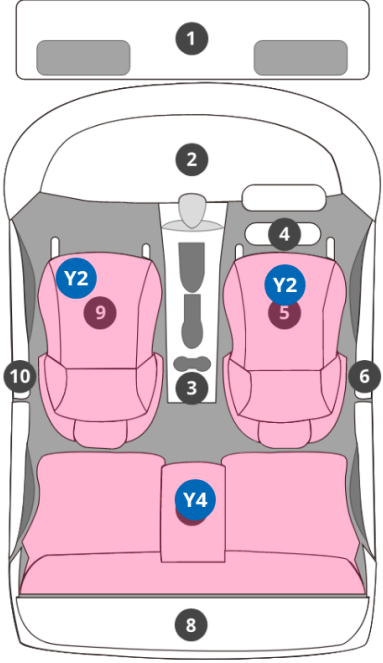
<p>a : Cut, Fray d : Loose, Deformed k : Animal Hair s : Smell t : Cigarette Burns x : Defective y : Stain</p>

<p>A : Scratch AU : Scratch & Dent B : Modified C : Corrosion G : Stone chip P : Faded S : Rust SC : Rust & Corrosion U : Dent X : Defective Y : Crack, Gap</p>
<p>Remarks Rear Seat - Grime - Large / (R) Front Seat - Grime - Small / (L) Front Seat - Grime - Small</p>	<p>Remarks (R) Front Fender, Molding - Scratch - Minimal / (R) Front Door, Molding - Partially Missing - Yes / (R) Front Door, Molding - Scratch - Minimal / (R) Rear Door, Molding - Scratch - Minimal / (R) Step, In-panel, Side Spoiler - Scratch - Medium / Roof - Scratch - Minimal / (R) Rear Fender, Molding - Scratch - Minimal / Rear Bumper, Lamps, Panels - Scratch - Medium / Trunk Hood, Rear Gate - Crack, Gap - Medium / (L) Rear Fender, Molding - Scratch & Dent - Small / (L) Rear Door, Molding - Scratch - Minimal / (L) Front Door, Molding - Scratch - Small / (L) Mirror - Crack - Cracks / (L) Front Fender, Molding - Scratch - Minimal / Front Bumper, Grille, Lamps - Crack, Gap - Medium / Bonnet, Headlight - Scratch - Minimal</p>

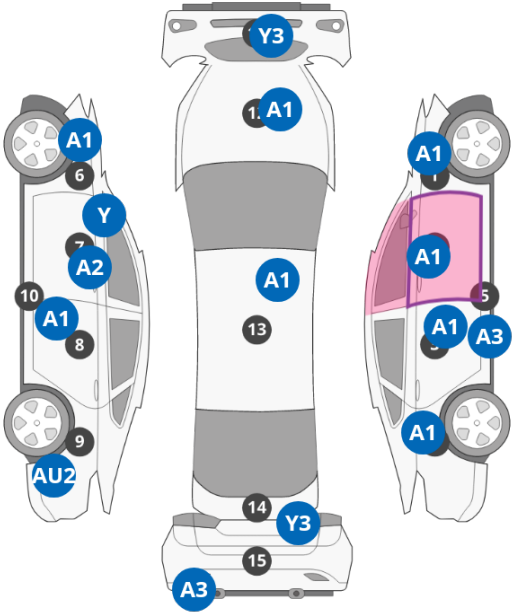
<p>Inspector Notes</p>
<p>With Lto plate, with spare tire, with jack and tools, 1key, no warranty booklet, scratches on headlights, Crack taillight, battery weak</p>
