General Information

Make	Toyota	Model	Vios
YOM	2025	Odo Meter Reading	48,017
Registration No.	NHS8466	Chassis No.	PA1B18F39R4271154
CC	1.3	Transmission	CVT
Fuel Type	Gas	Type of Body	Sedan
Colour	Black

Body / Panel Condition

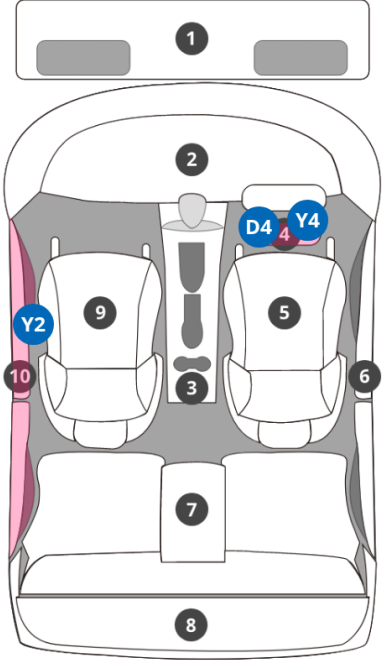
Interior Evaluation : C	Exterior Evaluation : E

<p>a : Cut, Fray d : Loose, Deformed k : Animal Hair s : Smell t : Cigarette Burns x : Defective y : Stain</p>

<p>A : Scratch AU : Scratch & Dent B : Modified C : Corrosion G : Stone chip P : Faded S : Rust SC : Rust & Corrosion U : Dent X : Defective Y : Crack, Gap</p>
<p>Remarks (L) Front Floor Mat - Worked - Large / (L) Front Trim - Grime - Small / (R) Front Floor Mat - Grime - Large</p>	<p>Remarks Bonnet, Headlight - Dent - Small / Rear Bumper, Lamps, Panels - Scratch - Large / (L) Front Door, Molding - Scratch & Dent - Medium / (L) Rear Door, Molding - Scratch - Small / (L) Rear Fender, Molding - Scratch - Small / (L) Front Fender, Molding - Scratch - Small / (R) Rear Door, Molding - Scratch - Large / (R) Front Door, Molding - Scratch - Large / Front Bumper, Grille, Lamps - Scratch & Dent - Medium / (R) Front Fender, Molding - Scratch - Small / (R) Rear Fender, Molding - Scratch - Small / Trunk Hood, Rear Gate - Scratch - Small</p>
