General Information

Make	Toyota	Model	Wigo
YOM	2023	Odo Meter Reading	33,178
Registration No.	CCF7188	Chassis No.	MHKAA1BC8PJ001230
CC	1.0	Transmission	CVT
Fuel Type	Gas	Type of Body	Hatchback
Colour	Silver

Body / Panel Condition

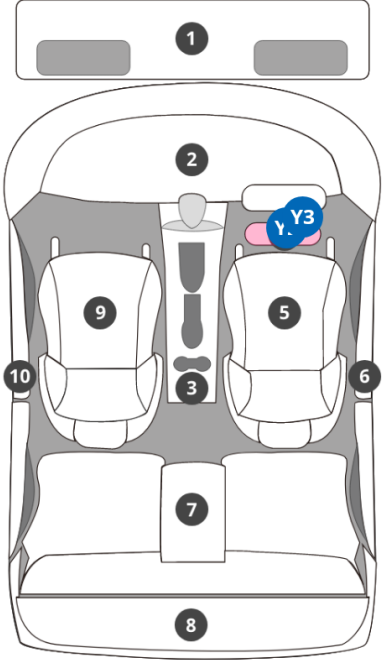
Interior Evaluation : B	Exterior Evaluation : B

<p>a : Cut, Fray d : Loose, Deformed k : Animal Hair s : Smell t : Cigarette Burns x : Defective y : Stain</p>

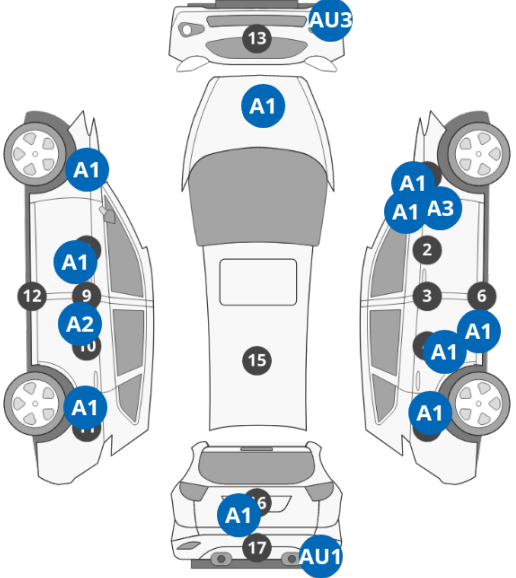
<p>A : Scratch AU : Scratch & Dent B : Modified C : Corrosion G : Stone chip P : Faded S : Rust SC : Rust & Corrosion U : Dent X : Defective Y : Crack, Gap</p>
Remarks (L) Front Floor Mat - Grime - Small / Mat Other - Grime - Medium	Remarks (R) Front Fender - Repair Traces - Yes / Bonnet - Repair Traces - Yes / (L) Front Fender - Repair Traces - Yes / (R) Front Fender, Molding - Scratch - Minimal / (R) Front Door, Molding - Scratch - Medium / (R) Step, In-panel, Side Spoiler - Scratch - Minimal / (R) Rear Door, Molding - Scratch - Minimal / (R) Rear Fender, Molding - Scratch - Minimal / Rear Bumper, Lamps, Panels - Scratch & Dent - Minimal / Trunk Hood, Rear Gate - Scratch - Minimal / (L) Rear Fender, Molding - Scratch - Minimal / (L) Rear Door, Molding - Scratch - Small / (L) Front Door, Molding - Scratch - Minimal / (R) Mirror - Scratch - Minimal / (L) Front Fender, Molding - Scratch - Minimal / Front Bumper, Grille, Lamps - Scratch & Dent - Medium / Bonnet, Headlight - Scratch - Minimal
