General Information

Make	Toyota	Model	Vios
YOM	2025	Odo Meter Reading	23,717
Registration No.	CCF4512	Chassis No.	PA1B18F30R4266098
CC	1.3	Transmission	CVT
Fuel Type	Gas	Type of Body	Sedan
Colour	Blue

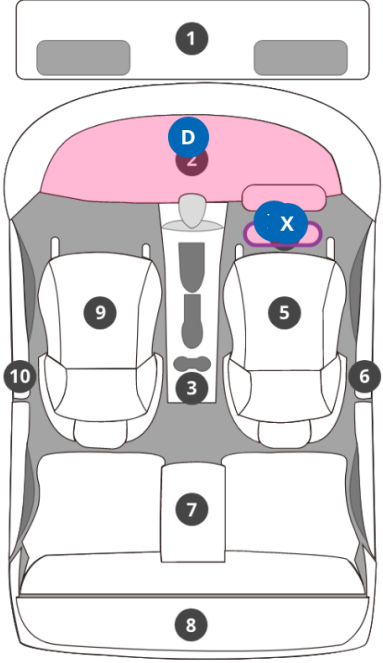
Interior Evaluation : B	Exterior Evaluation : C

<p>a : Cut, Fray d : Loose, Deformed k : Animal Hair s : Smell t : Cigarette Burns x : Defective y : Stain</p>

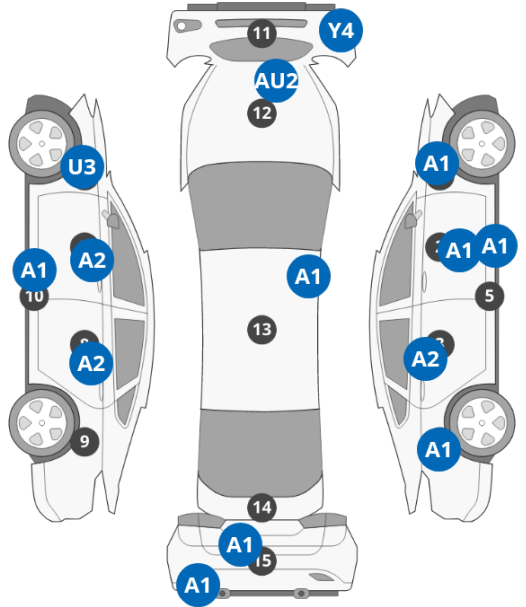
<p>A : Scratch AU : Scratch & Dent B : Modified C : Corrosion G : Stone chip P : Faded S : Rust SC : Rust & Corrosion U : Dent X : Defective Y : Crack, Gap</p>
<p>Remarks (R) Front Floor Mat - Missing - Yes / (L) Front Floor Mat - Missing - Yes / Dashboard - Traces of Adhesive Tape - Yes</p>	<p>Remarks (R) Front Fender, Molding - Scratch - Minimal / (R) Front Door, Molding - Scratch - Minimal / (R) Step, In-panel, Side Spoiler - Scratch - Minimal / Roof - Scratch - Minimal / (R) Rear Door, Molding - Scratch - Small / (R) Rear Fender, Molding - Scratch - Minimal / Rear Bumper, Lamps, Panels - Scratch - Minimal / Trunk Hood, Rear Gate - Scratch - Minimal / (L) Rear Door, Molding - Scratch - Small / (L) Front Door, Molding - Scratch - Small / (L) Step, In-panel, Side Spoiler - Scratch - Minimal / (L) Front Fender, Molding - Dent - Medium / Bonnet, Headlight - Scratch & Dent - Small / Front Bumper, Grille, Lamps - Crack, Gap - Large</p>

<p>Inspector Notes</p>
<p>With Lto plate, with warranty booklet, with spare tire and jack, 1key, no tools, scratches on headlights and taillights</p>
