## General Information

<b>Make</b>	Toyota	<b>Model</b>	Vios
<b>YOM</b>	2024	<b>Odo Meter Reading</b>	21,121
<b>Registration No.</b>	BAG2864	<b>Chassis No.</b>	PA1B18F34R4255167
<b>CC</b>	1.3	<b>Transmission</b>	CVT
<b>Fuel Type</b>	Gas	<b>Type of Body</b>	Sedan
<b>Colour</b>	Red

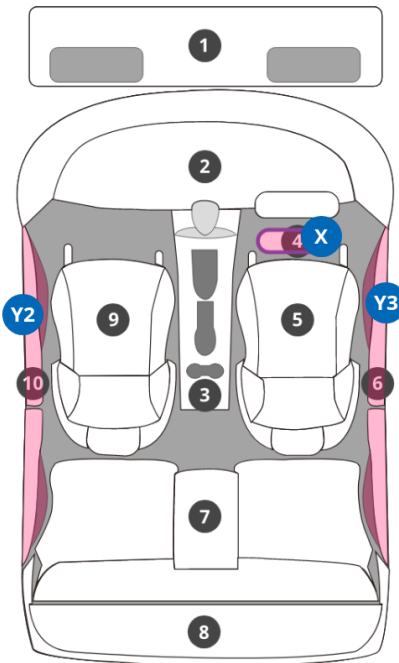
<b>Interior Evaluation :</b> <span style="float: right; color: red; font-weight: bold;">B</span>	<b>Exterior Evaluation :</b> <span style="float: right; color: red; font-weight: bold;">C</span>

<p><b>a</b> : Cut, Fray <b>d</b> : Loose, Deformed <b>k</b> : Animal Hair <b>s</b> : Smell <b>t</b> : Cigarette Burns <b>x</b> : Defective <b>y</b> : Stain</p>

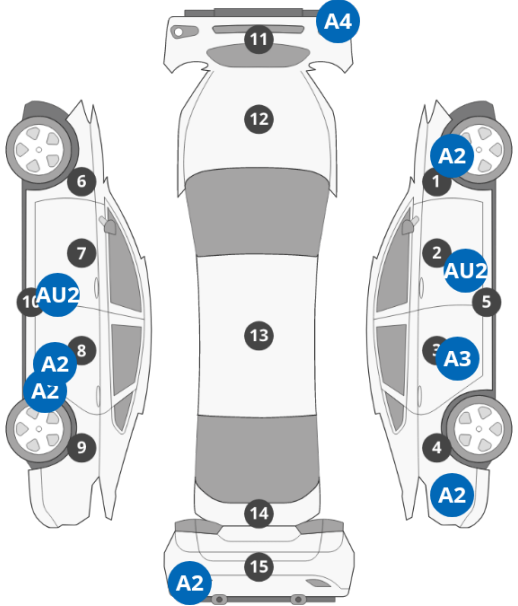
<p><b>A</b> : Scratch <b>AU</b> : Scratch &amp; Dent <b>B</b> : Modified <b>C</b> : Corrosion <b>G</b> : Stone chip <b>P</b> : Faded <b>S</b> : Rust <b>SC</b> : Rust &amp; Corrosion <b>U</b> : Dent <b>X</b> : Defective <b>Y</b> : Crack, Gap</p>
<p><b>Remarks</b> (R) Front Floor Mat - Missing - Yes / (L) Front Trim - Grime - Small / (R) Front Trim - Grime - Medium</p>	<p><b>Remarks</b> Rear Bumper, Lamps, Panels - Scratch - Small / (L) Rear Fender, Molding - Scratch - Small / (L) Rear Door, Molding - Scratch - Small / (L) Front Door, Molding - Scratch &amp; Dent - Small / Front Bumper, Grille, Lamps - Scratch - Large / (R) Rear Door, Molding - Scratch - Medium / (R) Front Door, Molding - Scratch &amp; Dent - Small / (R) Rear Fender, Molding - Scratch - Small / (R) Front Fender, Molding - Scratch - Small</p>
