General Information

Make	Toyota	Model	Wigo
YOM	2024	Odo Meter Reading	23,496
Registration No.	NKA9262	Chassis No.	MHKAA1BC1PJ013221
CC	1.0	Transmission	CVT
Fuel Type	Gas	Type of Body	Hatchback
Colour	Silver

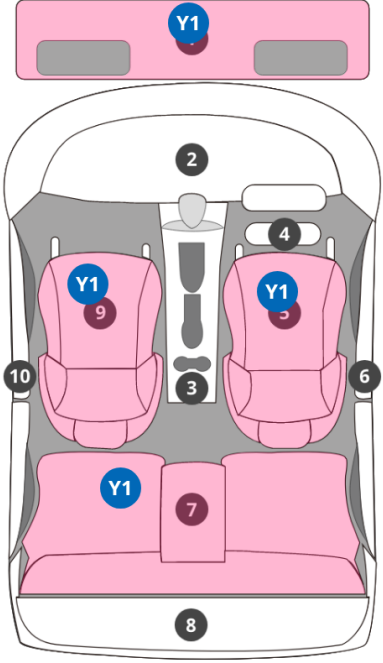
Interior Evaluation : A	Exterior Evaluation : D

<p>a : Cut, Fray d : Loose, Deformed k : Animal Hair s : Smell t : Cigarette Burns x : Defective y : Stain</p>

<p>A : Scratch AU : Scratch & Dent B : Modified C : Corrosion G : Stone chip P : Faded S : Rust SC : Rust & Corrosion U : Dent X : Defective Y : Crack, Gap</p>
<p>Remarks (L) Front Seat - Grime - Minimal / (R) Front Seat - Grime - Minimal / Rear Seat - Grime - Minimal / Ceiling - Grime - Minimal</p>	<p>Remarks (R) Front Fender, Molding - Scratch & Dent - Small / (R) Mirror - Scratch - Minimal / (R) Front Door, Molding - Scratch - Minimal / (R) Rear Door, Molding - Scratch - Small / (R) Step, In-panel, Side Spoiler - Scratch - Minimal / (R) Rear Fender, Molding - Scratch - Minimal / Rear Bumper, Lamps, Panels - Scratch - Large / Trunk Hood, Rear Gate - Scratch - Minimal / Roof - Scratch - Minimal / (L) Rear Fender, Molding - Scratch - Small / (L) Rear Door, Molding - Scratch - Minimal / (L) Step, In-panel, Side Spoiler - Scratch - Minimal / (L) Front Door, Molding - Scratch & Dent - Small / (L) Mirror - Scratch - Minimal / (L) Front Fender, Molding - Scratch - Minimal / Front Bumper, Grille, Lamps - Scratch - Medium / Bonnet, Headlight - Scratch & Dent - Large</p>

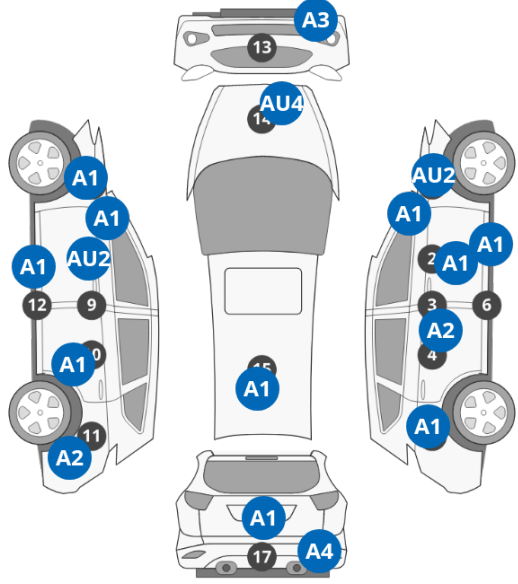
With Lto plate, with spare tire, 1key, no warranty booklet, no jack and tools, scratches on headlights and taillights, battery weak
