General Information

Make	Suzuki	Model	Dzire
YOM	2024	Odo Meter Reading	20,564
Registration No.	NFF9387	Chassis No.	MBHZF63S6RG470764
CC	1.2	Transmission	A/T
Fuel Type	Gas	Type of Body	Sedan
Colour	Red

Body / Panel Condition

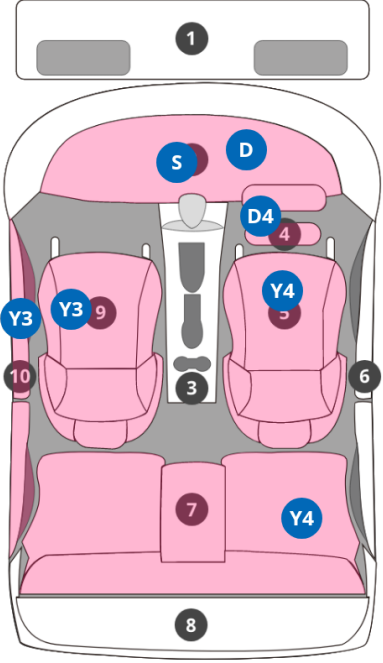
Interior Evaluation : C	Exterior Evaluation : E

<p>a : Cut, Fray d : Loose, Deformed k : Animal Hair s : Smell t : Cigarette Burns x : Defective y : Stain</p>

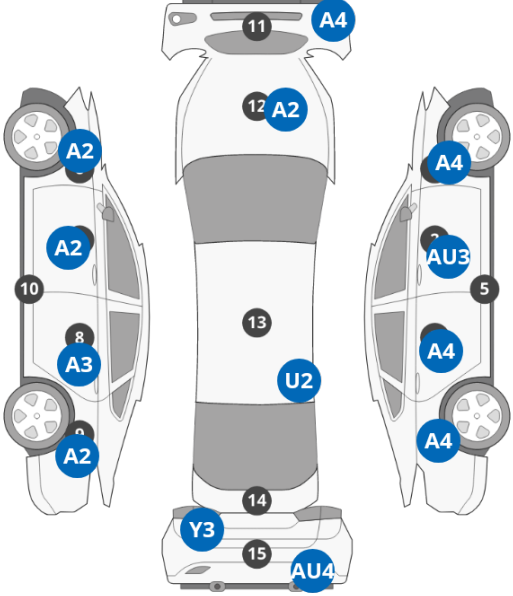
<p>A : Scratch AU : Scratch & Dent B : Modified C : Corrosion G : Stone chip P : Faded S : Rust SC : Rust & Corrosion U : Dent X : Defective Y : Crack, Gap</p>
<p>Remarks Overall Interior - Smell - Yes / Dashboard - Traces of Adhesive Tape - Yes / (L) Front Trim - Grime - Medium / (R) Front Seat - Grime - Large / Rear Seat - Grime - Large / (L) Front Floor Mat - Worked - Large / (L) Front Seat - Grime - Medium</p>	<p>Remarks Rear Bumper, Lamps, Panels - Scratch & Dent - Large / Trunk Hood, Rear Gate - Crack, Gap - Medium / (L) Rear Fender, Molding - Scratch - Small / (L) Rear Door, Molding - Scratch - Medium / (L) Front Door, Molding - Scratch - Small / Bonnet, Headlight - Scratch - Small / (L) Front Fender, Molding - Scratch - Small / (R) Front Fender, Molding - Scratch - Large / Front Bumper, Grille, Lamps - Scratch - Large / (R) Front Door, Molding - Scratch & Dent - Medium / (R) Rear Door, Molding - Scratch - Large / (R) Rear Fender, Molding - Scratch - Large / Roof - Dent - Small</p>
