## General Information

<b>Make</b>	Toyota	<b>Model</b>	Vios
<b>YOM</b>	2025	<b>Odo Meter Reading</b>	18,001
<b>Registration No.</b>	NKS5351	<b>Chassis No.</b>	PA1B18F35S4265068
<b>CC</b>	1.3	<b>Transmission</b>	CVT
<b>Fuel Type</b>	Gas	<b>Type of Body</b>	Sedan
<b>Colour</b>	Silver

## Body / Panel Condition

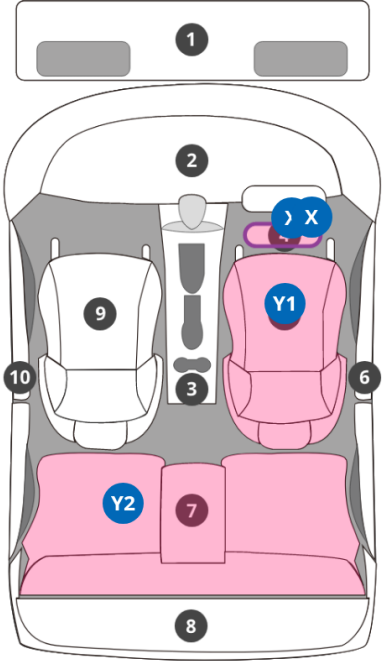
<b>Interior Evaluation :</b> <span style="float: right; color: red; font-weight: bold;">B</span>	<b>Exterior Evaluation :</b> <span style="float: right; color: red; font-weight: bold;">C</span>

<p><b>a</b> : Cut, Fray <b>d</b> : Loose, Deformed <b>k</b> : Animal Hair <b>s</b> : Smell <b>t</b> : Cigarette Burns <b>x</b> : Defective <b>y</b> : Stain</p>

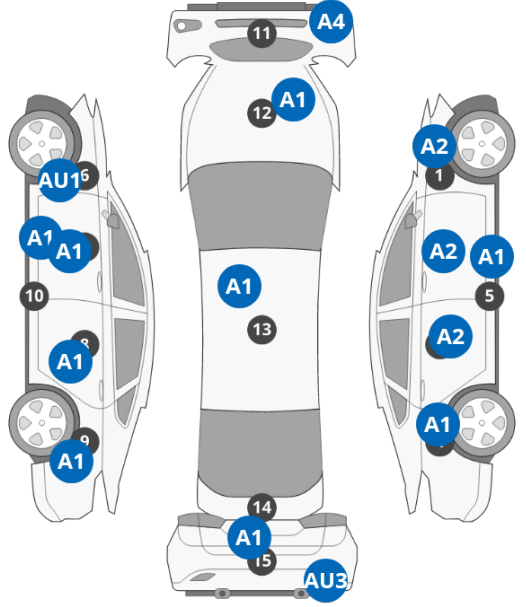
<p><b>A</b> : Scratch <b>AU</b> : Scratch &amp; Dent <b>B</b> : Modified <b>C</b> : Corrosion <b>G</b> : Stone chip <b>P</b> : Faded <b>S</b> : Rust <b>SC</b> : Rust &amp; Corrosion <b>U</b> : Dent <b>X</b> : Defective <b>Y</b> : Crack, Gap</p>
<p><b>Remarks</b> (R) Front Floor Mat - Missing - Yes / Mat Other - Missing - Yes / Rear Seat - Grime - Small / (R) Front Seat - Grime - Minimal</p>	<p><b>Remarks</b> (R) Front Fender, Molding - Scratch - Small / (R) Front Door, Molding - Scratch - Small / (R) Step, In-panel, Side Spoiler - Scratch - Minimal / (R) Rear Door, Molding - Scratch - Small / (R) Rear Fender, Molding - Scratch - Minimal / Rear Bumper, Lamps, Panels - Scratch &amp; Dent - Medium / Trunk Hood, Rear Gate - Scratch - Minimal / (L) Rear Fender, Molding - Scratch - Minimal / (L) Rear Door, Molding - Scratch - Minimal / (L) Step, In-panel, Side Spoiler - Scratch - Minimal / (L) Front Door, Molding - Scratch - Minimal / (L) Front Fender, Molding - Scratch &amp; Dent - Minimal / Front Bumper, Grille, Lamps - Scratch - Large / Bonnet, Headlight - Scratch - Minimal / Roof - Scratch - Minimal</p>

<p><b>Inspector Notes</b></p>
<p>No Lto plate, with warranty booklet, with spare tire, 1key, no jack and tools, scratches on headlights and taillights, grime on carpet,</p>
