General Information

Make	Toyota	Model	Vios
YOM	2023	Odo Meter Reading	33,123
Registration No.	NHI9365	Chassis No.	PA1B18F33P4209522
CC	1.3	Transmission	CVT
Fuel Type	Gas	Type of Body	Sedan
Colour	Blackish Red Mica

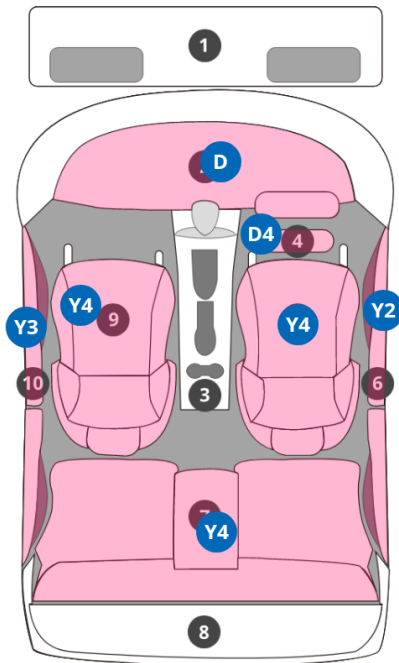
Interior Evaluation : D	Exterior Evaluation : E

<p>a : Cut, Fray d : Loose, Deformed k : Animal Hair s : Smell t : Cigarette Burns x : Defective y : Stain</p>

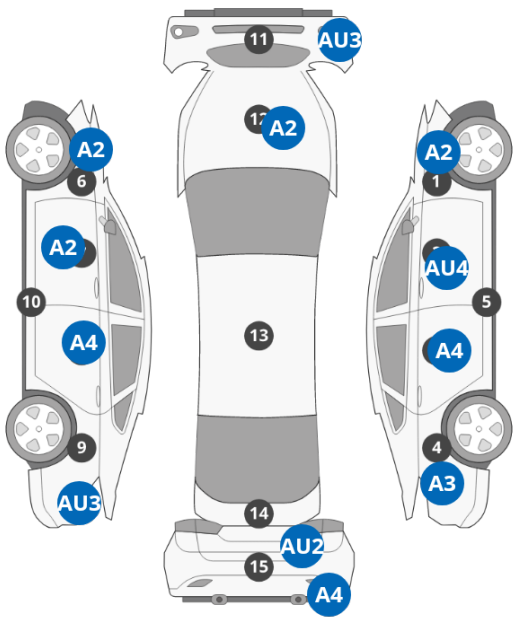
<p>A : Scratch AU : Scratch & Dent B : Modified C : Corrosion G : Stone chip P : Faded S : Rust SC : Rust & Corrosion U : Dent X : Defective Y : Crack, Gap</p>
<p>Remarks Rear Seat - Grime - Large / (R) Front Trim - Grime - Small / (R) Front Seat - Grime - Large / (L) Front Trim - Grime - Medium / (L) Front Seat - Grime - Large / (L) Front Floor Mat - Worked - Large / Dashboard - Traces of Adhesive Tape - Yes</p>	<p>Remarks Front Bumper, Grille, Lamps - Scratch & Dent - Medium / (L) Front Door, Molding - Scratch - Small / (L) Front Fender, Molding - Scratch - Small / Bonnet, Headlight - Scratch - Small / (R) Front Fender, Molding - Scratch - Small / (R) Front Door, Molding - Scratch & Dent - Large / (R) Rear Door, Molding - Scratch - Large / (R) Rear Fender, Molding - Scratch - Medium / Rear Bumper, Lamps, Panels - Scratch - Large / Trunk Hood, Rear Gate - Scratch & Dent - Small / (L) Rear Fender, Molding - Scratch & Dent - Medium / (L) Rear Door, Molding - Scratch - Large</p>
