General Information

Make	Toyota	Model	Hiace
YOM	2023	Odo Meter Reading	68,705
Registration No.	CBT8990	Chassis No.	JTFJT02P5P5033425
CC	3.0	Transmission	M/T
Fuel Type	Diesel	Type of Body	Utility Vehicle
Colour	Silver

Body / Panel Condition

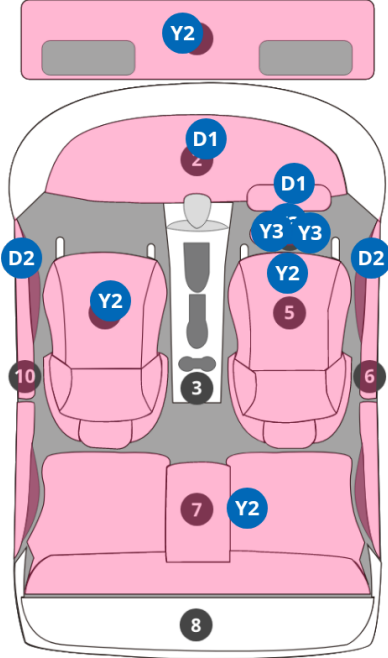
Interior Evaluation : C	Exterior Evaluation : D

<p>a : Cut, Fray d : Loose, Deformed k : Animal Hair s : Smell t : Cigarette Burns x : Defective y : Stain</p>

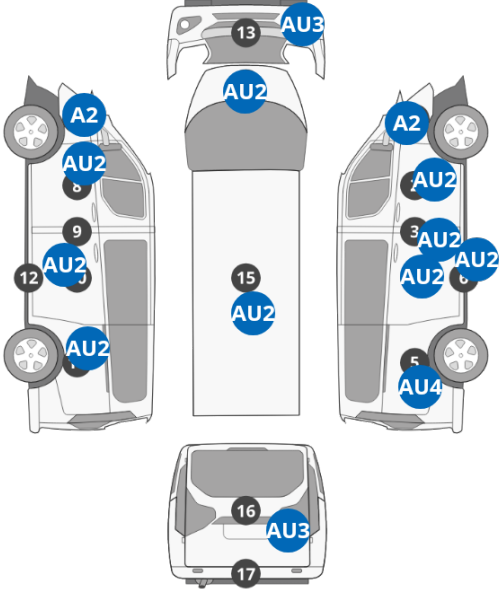
<p>A : Scratch AU : Scratch & Dent B : Modified C : Corrosion G : Stone chip P : Faded S : Rust SC : Rust & Corrosion U : Dent X : Defective Y : Crack, Gap</p>
Remarks (L) Front Seat - Grime - Small / (R) Front Seat - Grime - Small / (L) Front Trim - Worked - Small / (R) Front Trim - Worked - Small / Dashboard - Worked - Minimal / Glove Box - Worked - Minimal / (R) Front Floor Mat - Grime - Medium / Mat Other - Grime - Medium / Rear Seat - Grime - Small / Ceiling - Grime - Small / (L) Front Floor Mat - Grime - Medium	Remarks Roof - Repair Traces - Yes / (L) Rear Fender, Molding - Scratch & Dent - Small / Trunk Hood, Rear Gate - Scratch & Dent - Medium / (R) Rear Fender, Molding - Scratch & Dent - Large / (R) Rear Door, Molding - Scratch & Dent - Small / (R) Center Panel - Scratch & Dent - Small / (R) Front Door, Molding - Scratch & Dent - Small / (R) Step, In-panel, Side Spoiler - Scratch & Dent - Small / Front Panel - Scratch & Dent - Small / Front Bumper, Grille, Lamps - Scratch & Dent - Medium / Roof - Scratch & Dent - Small / (L) Front Door, Molding - Scratch & Dent - Small / (L) Rear Door, Molding - Scratch & Dent - Small / (L) Front Fender, Molding - Scratch - Small / (R) Front Fender, Molding - Scratch - Small

Inspector Notes
with LTO plate, with spare tire, no spare key, no warranty and manual booklet, scratches on taillight and headlight, no reverse camera, issue on rear seat.
