General Information

Make	Toyota	Model	Wigo
YOM	2024	Odo Meter Reading	12,087
Registration No.	CCD3803	Chassis No.	MHKAA1BC4RJ020005
CC	1.0	Transmission	CVT
Fuel Type	Gas	Type of Body	Hatchback
Colour	Gray

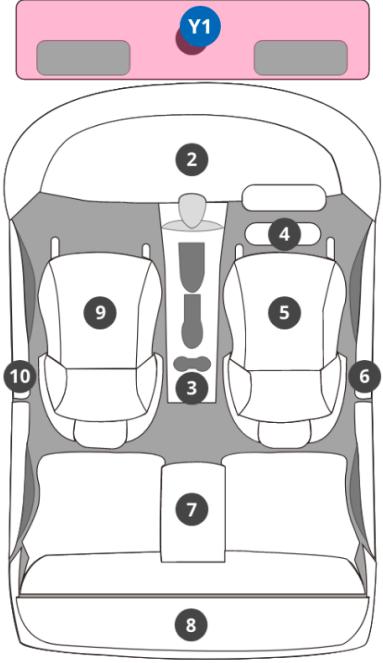
<p>a : Cut, Fray d : Loose, Deformed k : Animal Hair s : Smell t : Cigarette Burns x : Defective y : Stain</p>

<p>A : Scratch AU : Scratch & Dent B : Modified C : Corrosion G : Stone chip P : Faded S : Rust SC : Rust & Corrosion U : Dent X : Defective Y : Crack, Gap</p>
Remarks Ceiling - Grime - Minimal	Remarks (L) Rear Door - Repair Traces - Yes / (L) Rear Fender - Repair Traces - Yes / (R) Front Fender, Molding - Scratch - Minimal / (R) Mirror - Scratch - Minimal / (R) Front Door, Molding - Scratch & Dent - Small / (R) Rear Door, Molding - Scratch & Dent - Large / (R) Step, In-panel, Side Spoiler - Scratch - Minimal / Roof - Scratch - Minimal / (R) Rear Fender, Molding - Scratch - Minimal / Trunk Hood, Rear Gate - Scratch - Minimal / Rear Bumper, Lamps, Panels - Scratch - Minimal / (L) Rear Fender, Molding - Repair mark - Yes / (L) Rear Fender, Molding - Scratch - Minimal / (L) Rear Door, Molding - Scratch - Minimal / (L) Step, In-panel, Side Spoiler - Scratch - Minimal / (L) Front Door, Molding - Scratch - Minimal / (L) Front Fender, Molding - Scratch - Minimal / Bonnet, Headlight - Scratch - Small / Front Bumper, Grille, Lamps - Scratch - Minimal

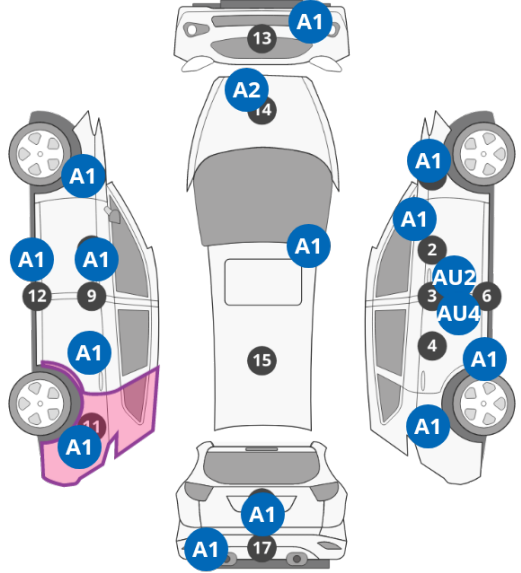
Inspector Notes
With Lto plate, with spare tire and jack, 1key, no warranty booklet and tools, scratches on headlights and taillights
