General Information

Make	Toyota	Model	Wigo
YOM	2024	Odo Meter Reading	8,460
Registration No.	NKC8410	Chassis No.	MHKAA1BC7RJ020144
CC	1.0	Transmission	CVT
Fuel Type	Gas	Type of Body	Hatchback
Colour	Gray

Body / Panel Condition

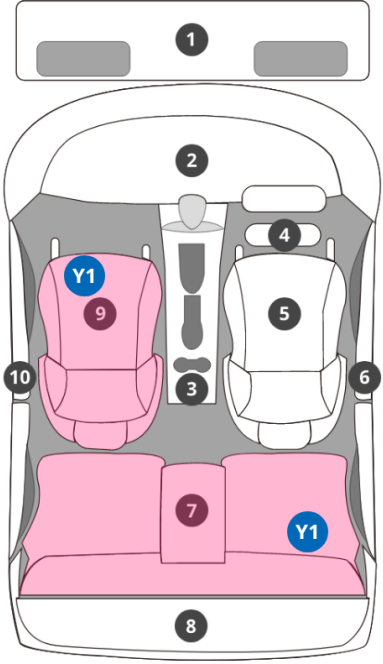
Interior Evaluation : A	Exterior Evaluation : C

<p>a : Cut, Fray d : Loose, Deformed k : Animal Hair s : Smell t : Cigarette Burns x : Defective y : Stain</p>

<p>A : Scratch AU : Scratch & Dent B : Modified C : Corrosion G : Stone chip P : Faded S : Rust SC : Rust & Corrosion U : Dent X : Defective Y : Crack, Gap</p>
<p>Remarks (L) Front Seat - Grime - Minimal / Rear Seat - Grime - Minimal</p>	<p>Remarks (R) Front Fender, Molding - Scratch - Minimal / (R) Front Door, Molding - Scratch - Minimal / (R) Step, In-panel, Side Spoiler - Scratch - Minimal / (R) Rear Door, Molding - Scratch - Minimal / (R) Rear Fender, Molding - Scratch - Minimal / Trunk Hood, Rear Gate - Scratch & Dent - Small / Rear Bumper, Lamps, Panels - Scratch - Minimal / (L) Rear Fender, Molding - Scratch - Minimal / (L) Rear Door, Molding - Scratch - Minimal / (L) Step, In-panel, Side Spoiler - Scratch - Minimal / (L) Front Door, Molding - Scratch - Minimal / (L) Front Fender, Molding - Scratch & Dent - Medium / Front Bumper, Grille, Lamps - Scratch & Dent - Large / Bonnet, Headlight - Scratch - Medium</p>
