General Information

Make	Toyota	Model	Rush
YOM	2023	Odo Meter Reading	57,194
Registration No.	EAF5114	Chassis No.	MHKE8FF3PNK047946
CC	1.5	Transmission	A/T
Fuel Type	Gas	Type of Body	SUV
Colour	Red Mica Metallic

Body / Panel Condition

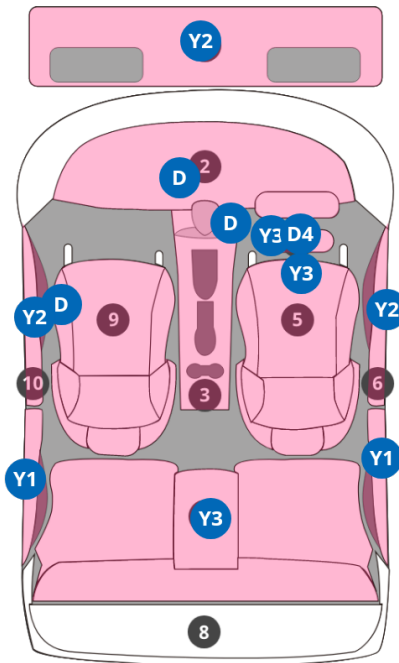
Interior Evaluation : D	Exterior Evaluation : D

<p>a : Cut, Fray d : Loose, Deformed k : Animal Hair s : Smell t : Cigarette Burns x : Defective y : Stain</p>

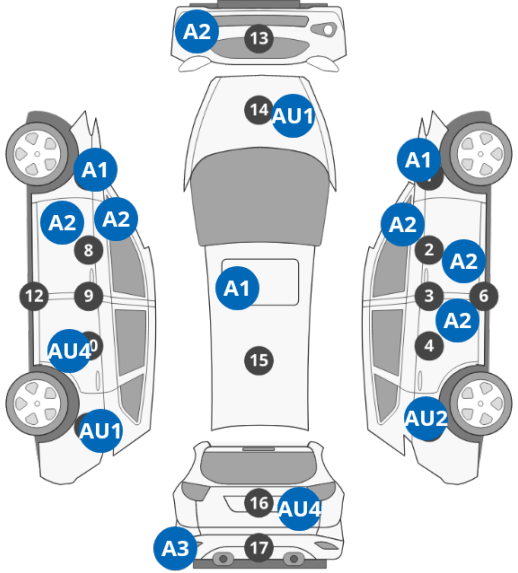
<p>A : Scratch AU : Scratch & Dent B : Modified C : Corrosion G : Stone chip P : Faded S : Rust SC : Rust & Corrosion U : Dent X : Defective Y : Crack, Gap</p>
<p>Remarks Rear Seat - Grime - Medium / (L) Front Seat - Worn - Yes / (R) Front Seat - Grime - Medium / Mat Other - Grime - Medium / Mat Other - Worked - Large / (L) Front Trim - Grime - Small / (R) Front Trim - Grime - Small / Dashboard - Traces of Adhesive Tape - Yes / Console, Switches, Vents - Traces of Adhesive Tape - Yes / Ceiling - Grime - Small / (R) Rear Trim - Grime - Minimal / (L) Rear Trim - Grime - Minimal</p>	<p>Remarks Trunk Hood, Rear Gate - Repair Traces - Yes / Roof - Repair Traces - Yes / (R) Front Fender, Molding - Scratch - Minimal / (R) Mirror - Scratch - Small / (R) Front Door, Molding - Scratch - Small / (R) Rear Door, Molding - Scratch - Small / (R) Rear Fender, Molding - Scratch & Dent - Small / Rear Bumper, Lamps, Panels - Scratch - Medium / Trunk Hood, Rear Gate - Scratch & Dent - Large / (L) Rear Fender, Molding - Scratch & Dent - Minimal / (L) Rear Door, Molding - Scratch & Dent - Large / (L) Mirror - Scratch - Small / (L) Front Door, Molding - Scratch - Small / (L) Front Fender, Molding - Scratch - Minimal / Bonnet, Headlight - Scratch & Dent - Minimal / Front Bumper, Grille, Lamps - Scratch - Small / Roof - Scratch - Minimal</p>
