General Information

Make	Toyota	Model	Vios
YOM	2023	Odo Meter Reading	35,396
Registration No.	NFC7502	Chassis No.	PA1B18F38P4222508
CC	1.3	Transmission	CVT
Fuel Type	Gas	Type of Body	Sedan
Colour	Black

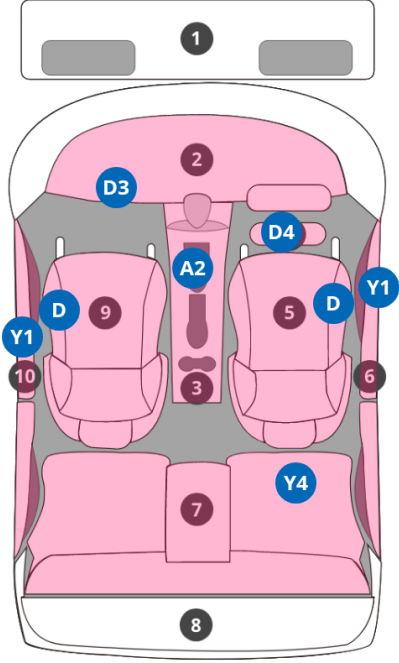
Interior Evaluation : C	Exterior Evaluation : E

<p>a : Cut, Fray d : Loose, Deformed k : Animal Hair s : Smell t : Cigarette Burns x : Defective y : Stain</p>

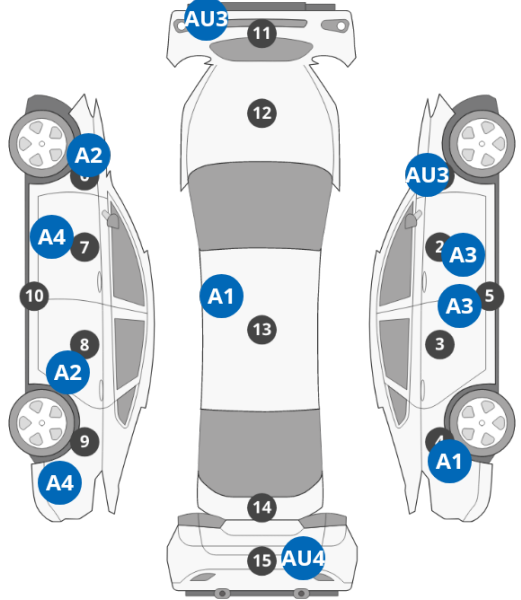
<p>A : Scratch AU : Scratch & Dent B : Modified C : Corrosion G : Stone chip P : Faded S : Rust SC : Rust & Corrosion U : Dent X : Defective Y : Crack, Gap</p>
<p>Remarks Carpet - Worked - Large / (R) Rear Trim - Grime - Minimal / (R) Front Seat - Worn - Yes / (L) Front Seat - Worn - Yes / Rear Seat - Grime - Large / Dashboard - Loose, Deformed - Medium / Knobs - Worn, Peel, Crack - Small / (L) Front Trim - Grime - Minimal</p>	<p>Remarks (R) Front Fender, Molding - Scratch & Dent - Medium / (R) Front Door, Molding - Scratch - Medium / (R) Rear Door, Molding - Scratch - Medium / (R) Rear Fender, Molding - Scratch - Minimal / Trunk Hood, Rear Gate - Scratch & Dent - Large / (L) Rear Fender, Molding - Scratch - Large / (L) Rear Door, Molding - Scratch - Small / (L) Front Door, Molding - Scratch - Large / (L) Front Fender, Molding - Scratch - Small / Front Bumper, Grille, Lamps - Scratch & Dent - Medium / Bonnet, Headlight - Scratch - Small / Roof - Scratch - Minimal</p>
