## General Information

Date & Time: 24, Feb, 2026 16:30

<b>Make</b>	Toyota	<b>Model</b>	Innova
<b>YOM</b>	2023	<b>Odo Meter Reading</b>	146,945
<b>Registration No.</b>	NHI6047	<b>Chassis No.</b>	PA2CA8EM1P0119089
<b>CC</b>	2.8	<b>Transmission</b>	M/T
<b>Fuel Type</b>	Diesel	<b>Type of Body</b>	Wagon
<b>Colour</b>	Silver

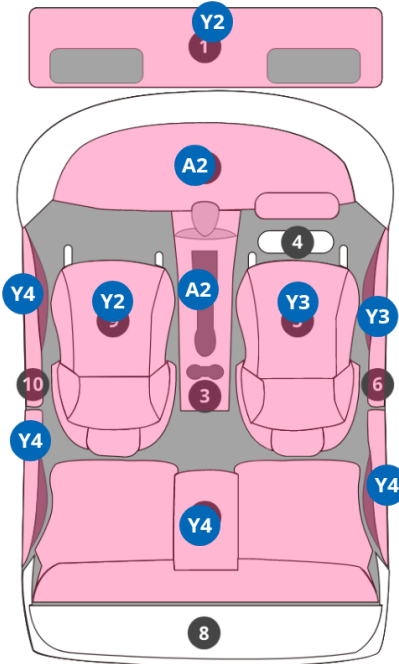
<b>Interior Evaluation :</b> <span style="float: right;"><b>E</b></span>	<b>Exterior Evaluation :</b> <span style="float: right;"><b>E</b></span>

<p><b>a</b> : Cut, Fray <b>d</b> : Loose, Deformed <b>k</b> : Animal Hair <b>s</b> : Smell <b>t</b> : Cigarette Burns <b>x</b> : Defective <b>y</b> : Stain</p>

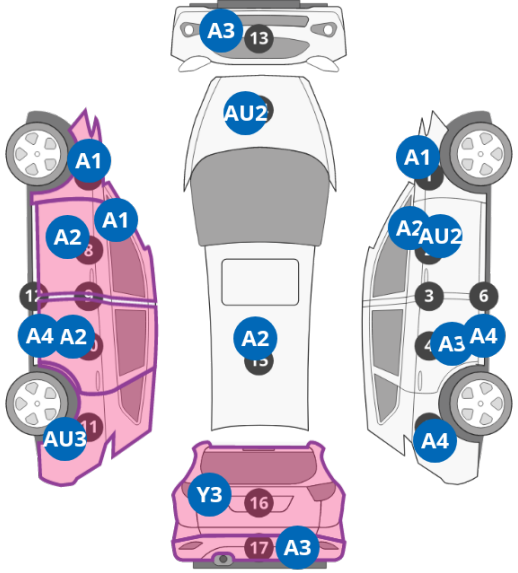
<p><b>A</b> : Scratch <b>AU</b> : Scratch &amp; Dent <b>B</b> : Modified <b>C</b> : Corrosion <b>G</b> : Stone chip <b>P</b> : Faded <b>S</b> : Rust <b>SC</b> : Rust &amp; Corrosion <b>U</b> : Dent <b>X</b> : Defective <b>Y</b> : Crack, Gap</p>
<p><b>Remarks</b> (R) Front Seat - Grime - Medium / (R) Front Trim - Grime - Medium / Rear Seat - Grime - Large / (R) Rear Trim - Grime - Large / (L) Rear Trim - Grime - Large / (L) Front Trim - Grime - Large / (L) Front Seat - Grime - Small / Dashboard - Worn, Scratch, Cut, Crack - Small / Ceiling - Grime - Small / Console, Switchs, Vents - Worn, Scratch, Cut, Crack - Small</p>	<p><b>Remarks</b> (R) Front Door - Repair Traces - Yes / (R) Front Fender - Repair Traces - Yes / Bonnet - Repair Traces - Yes / (L) Front Fender - Repair Traces - Yes / (L) Front Door - Repair Traces - Yes / (L) Rear Door - Repair Traces - Yes / (L) Rear Fender - Repair Traces - Yes / Trunk Hood, Rear Gate - Repair Traces - Yes / (R) Rear Fender - Repair Traces - Yes / (R) Rear Door - Repair Traces - Yes / Roof - Repair Traces - Yes / (L) Rear Fender, Molding - Repair mark - Yes / Trunk Hood, Rear Gate - Repair mark - Yes / Rear Bumper, Lamps, Panels - Repair mark - Yes / (R) Rear Fender, Molding - Scratch - Large / (R) Rear Door, Molding - Scratch - Medium / (R) Mirror - Scratch - Small / (R) Front Door, Molding - Scratch &amp; Dent - Small / Trunk Hood, Rear Gate - Crack, Gap - Medium / (L) Rear Fender, Molding - Scratch &amp; Dent - Medium / (L) Rear Door, Molding - Repair mark - Yes / (L) Rear Door, Molding - Scratch - Small / (L) Step, In-panel, Side Spoiler - Scratch - Large / (L) Front Door, Molding - Repair mark - Yes / (L) Front Door, Molding - Scratch - Small / (L) Mirror - Scratch - Minimal / (L) Front Fender, Molding - Repair mark - Yes / Bonnet, Headlight - Scratch &amp; Dent - Small / Front Bumper, Grille, Lamps - Scratch - Medium / (L) Front Fender, Molding - Scratch - Minimal / (R) Front Fender, Molding - Scratch - Minimal / Roof - Scratch - Small / Rear Bumper, Lamps, Panels - Scratch - Medium / (R) Step, In-panel, Side Spoiler - Scratch - Large</p>
