General Information

Make	Toyota	Model	Vios
YOM	2025	Odo Meter Reading	15,011
Registration No.	FAT1857	Chassis No.	PA1B18F31S4286611
CC	1.3	Transmission	CVT
Fuel Type	Gas	Type of Body	Sedan
Colour	Blue

Body / Panel Condition

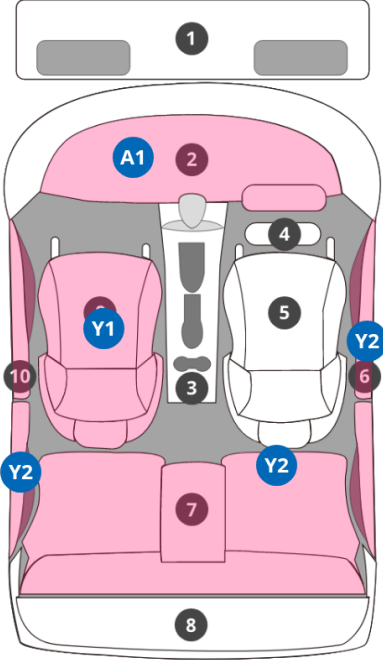
<p>a : Cut, Fray d : Loose, Deformed k : Animal Hair s : Smell t : Cigarette Burns x : Defective y : Stain</p>

<p>A : Scratch AU : Scratch & Dent B : Modified C : Corrosion G : Stone chip P : Faded S : Rust SC : Rust & Corrosion U : Dent X : Defective Y : Crack, Gap</p>
<p>Remarks (R) Front Trim - Grime - Small / (L) Front Seat - Grime - Minimal / Dashboard - Worn, Scratch, Cut, Crack - Minimal / (L) Rear Trim - Grime - Small / Rear Seat - Grime - Small</p>	<p>Remarks Front Bumper, Grille, Lamps - Scratch & Dent - Medium / (R) Front Fender, Molding - Dent - Small / (R) Rear Door, Molding - Scratch - Medium / (L) Front Fender, Molding - Scratch - Small / Trunk Hood, Rear Gate - Scratch - Small</p>
Frame Evaluation : A	Functional Evaluation : B
<p>Remarks Defects not found</p>	<p>Remarks Battery - Weak - Yes / Spare Key - Issue - Unexist</p>
