General Information

Make	Toyota	Model	Vios
YOM	2025	Odo Meter Reading	15,104
Registration No.	NHS9463	Chassis No.	PA1B18F39R4272272
CC	1.3	Transmission	CVT
Fuel Type	Gas	Type of Body	Sedan
Colour	Black

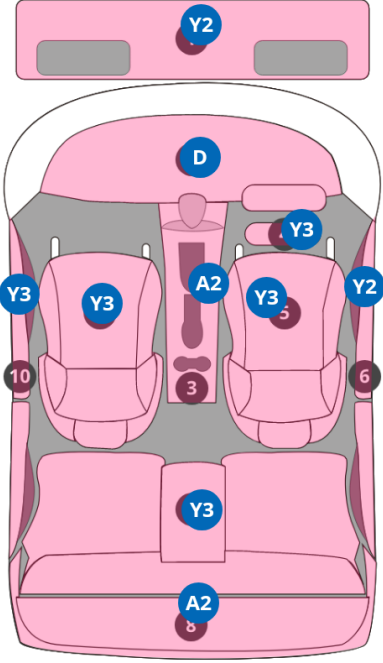
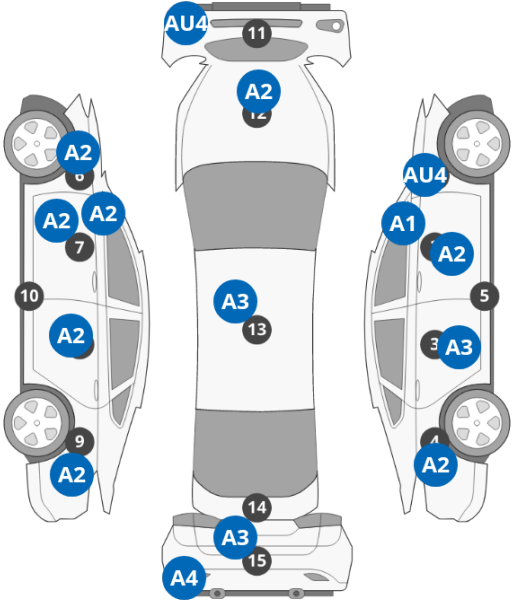
Interior Evaluation : C	Exterior Evaluation : E

<p>a : Cut, Fray d : Loose, Deformed k : Animal Hair s : Smell t : Cigarette Burns x : Defective y : Stain</p>	<p>A : Scratch AU : Scratch & Dent B : Modified C : Corrosion G : Stone chip P : Faded S : Rust SC : Rust & Corrosion U : Dent X : Defective Y : Crack, Gap</p>
<p>Remarks Trunk Room - Worn, Scratch, Cut, Crack - Small / Rear Seat - Grime - Medium / (R) Front Seat - Grime - Medium / (R) Front Trim - Grime - Small / (L) Front Trim - Grime - Medium / (L) Front Seat - Grime - Medium / (L) Front Floor Mat - Grime - Medium / Ceiling - Grime - Small / Dashboard - Traces of Adhesive Tape - Yes / Console, Switches, Vents - Worn, Scratch, Cut, Crack - Small</p>	<p>Remarks (R) Front Fender, Molding - Scratch & Dent - Large / Bonnet, Headlight - Scratch - Small / (L) Front Fender, Molding - Scratch - Small / Front Bumper, Grille, Lamps - Scratch & Dent - Large / (R) Mirror - Scratch - Minimal / (R) Front Door, Molding - Scratch - Small / (R) Rear Door, Molding - Scratch - Medium / (R) Rear Fender, Molding - Scratch - Small / Rear Bumper, Lamps, Panels - Scratch - Large / Trunk Hood, Rear Gate - Scratch - Medium / (L) Rear Fender, Molding - Scratch - Small / (L) Rear Door, Molding - Scratch - Small / (L) Mirror - Scratch - Small / (L) Front Door, Molding - Scratch - Small / Roof - Scratch - Medium</p>
