General Information

Make	Toyota	Model	Hilux Tamaraw
YOM	2025	Odo Meter Reading	33,999
Registration No.	NJC8411	Chassis No.	PAHACACA2S6425666
CC	2.4	Transmission	M/T
Fuel Type	Diesel	Type of Body	Utility Passenger
Colour	White

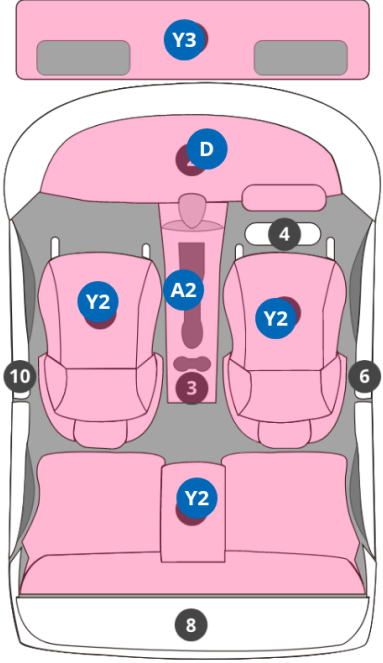
Interior Evaluation : B	Exterior Evaluation : E

<p>A : Scratch AU : Scratch & Dent B : Modified C : Corrosion G : Stone chip P : Faded S : Rust SC : Rust & Corrosion U : Dent X : Defective Y : Crack, Gap</p>
<p>Remarks Rear Seat - Grime - Small / (L) Front Seat - Grime - Small / (R) Front Seat - Grime - Small / Ceiling - Grime - Medium / Dashboard - Traces of Adhesive Tape - Yes / Console, Switches, Vents - Worn, Scratch, Cut, Crack - Small</p>	<p>Remarks Roof - Repair Traces - Yes / Rear Bumper, Lamps, Panels - Scratch - Medium / (R) Guard Frame - Scratch - Large / Cargo Bed Floor - Scratch & Dent - Large / Rear Gate - Scratch & Dent - Medium / Roof - Scratch - Small / (R) Front Door, Molding - Scratch & Dent - Medium / (R) Mirror - Scratch - Small / (R) Front Fender, Molding - Scratch - Small / Bonnet, Headlight - Scratch - Small / Front Bumper, Grille, Lamps - Scratch - Large / (L) Front Fender, Molding - Scratch - Small / (L) Mirror - Scratch - Small / (L) Front Door, Molding - Scratch - Small / (L) Guard Frame - Scratch - Small / Roof - Repair mark - Yes</p>
