## General Information

| Make | Toyota | Model | Wigo |

## Body / Panel Condition

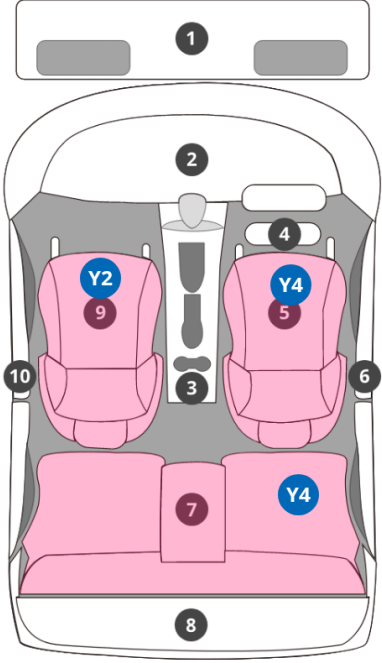
| <b>Interior Evaluation :</b> <b>C</b> | <b>Exterior Evaluation :</b> <b>C</b> |
| <b>Remarks</b><br>(R) Front Seat - Grime - Large / Rear Seat - Grime - Large / (L) Front Seat - Grime - Small | <b>Remarks</b><br>(L) Rear Fender - Repair Traces - Yes / (L) Rear Door, Molding - Scratch & Dent - Medium / (L) Rear Fender, Molding - Scratch & Dent - Large / Rear Bumper, Lamps, Panels - Scratch & Dent - Medium / Trunk Hood, Rear Gate - Scratch & Dent - Small / Front Bumper, Grille, Lamps - Scratch & Dent - Large / (L) Front Fender, Molding - Dent - Medium / Roof - Dent - Small |
