General Information

Make	Toyota	Model	Hilux
YOM	2025	Odo Meter Reading	27,197
Registration No.	VAB8085	Chassis No.	MR0JB8DD9R3553253
CC	2.4	Transmission	A/T
Fuel Type	Diesel	Type of Body	Pickup
Colour	Silver

Body / Panel Condition

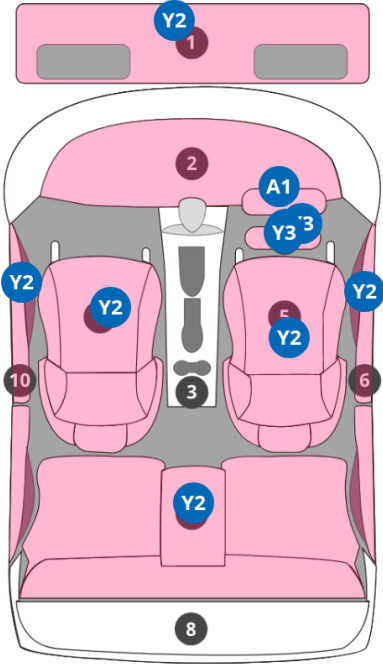
Interior Evaluation : C	Exterior Evaluation : E

<p>a : Cut, Fray d : Loose, Deformed k : Animal Hair s : Smell t : Cigarette Burns x : Defective y : Stain</p>

<p>A : Scratch AU : Scratch & Dent B : Modified C : Corrosion G : Stone chip P : Faded S : Rust SC : Rust & Corrosion U : Dent X : Defective Y : Crack, Gap</p>
<p>Remarks (L) Front Trim - Grime - Small / (R) Front Trim - Grime - Small / Rear Seat - Grime - Small / (L) Front Floor Mat - Grime - Medium / (R) Front Floor Mat - Grime - Medium / Mat Other - Grime - Medium / (L) Front Seat - Grime - Small / (R) Front Seat - Grime - Small / Ceiling - Grime - Small / Glove Box - Worn, Scratch, Cut, Crack - Minimal</p>	<p>Remarks (L) Front Fender, Molding - Scratch & Dent - Small / Bonnet, Headlight - Scratch & Dent - Medium / Front Bumper, Grille, Lamps - Crack, Gap - Large / (R) Front Fender, Molding - Scratch & Dent - Small / (R) Front Door, Molding - Scratch & Dent - Small / (R) Rear Door, Molding - Scratch - Medium / (L) Front Door, Molding - Scratch & Dent - Small / (L) Rear Door, Molding - Scratch & Dent - Small / (L) Step, In-panel, Side Spoiler - Scratch & Dent - Small / (L) Side Gate - Scratch & Dent - Small / Rear Gate - Scratch & Dent - Small / Rear Bumper, Lamps, Panels - Scratch & Dent - Small / Cargo Bed Floor - Scratch - Small / Cab Back Panel - Scratch - Medium / (R) Side Gate - Scratch & Dent - Medium / Roof - Dent - Large</p>

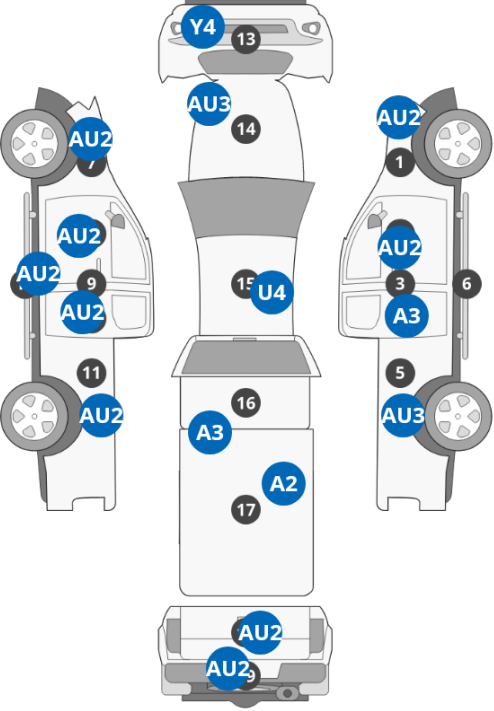
<p>Inspector Notes</p>
<p>with LTO plate, with spare tire, with reverse camera ,no tools and jack, no warranty and manual booklet, issue on headlight and foglamps, scratches on tailight,no spare key.</p>
