General Information

Make	Toyota	Model	Hilux
YOM	2022	Odo Meter Reading	75,191
Registration No.	FAO3213	Chassis No.	MR0CB8CB4N4290067
CC	2.4	Transmission	M/T
Fuel Type	Diesel	Type of Body	Utility Passenger
Colour	White

Body / Panel Condition

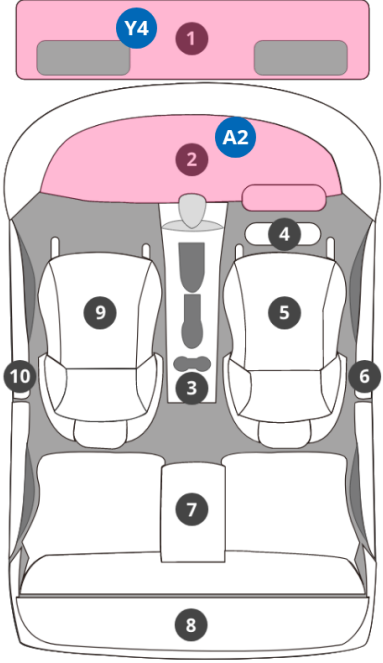
Interior Evaluation : C	Exterior Evaluation : B

<p>a : Cut, Fray d : Loose, Deformed k : Animal Hair s : Smell t : Cigarette Burns x : Defective y : Stain</p>

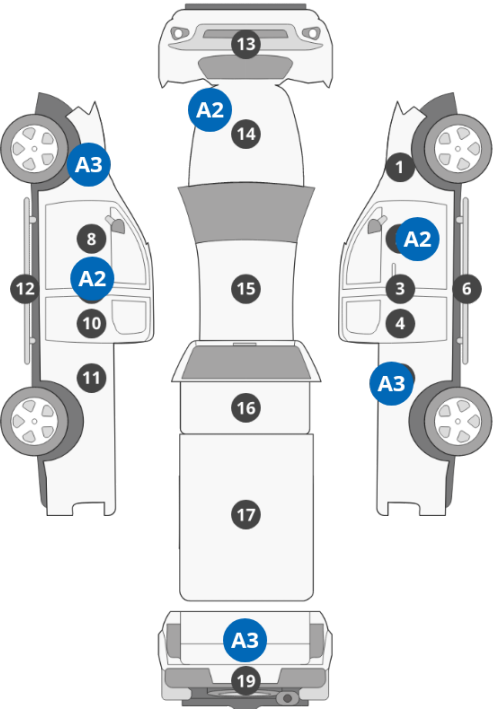
<p>A : Scratch AU : Scratch & Dent B : Modified C : Corrosion G : Stone chip P : Faded S : Rust SC : Rust & Corrosion U : Dent X : Defective Y : Crack, Gap</p>
<p>Remarks Ceiling - Grime - Large / Dashboard - Worn, Scratch, Cut, Crack - Small</p>	<p>Remarks Bonnet - Repair Traces - Yes / (L) Rear Corner Panel - Repair Traces - Yes / (R) Front Door, Molding - Scratch - Small / (R) Side Gate - Scratch - Medium / Rear Gate - Scratch - Medium / (L) Front Door, Molding - Scratch - Small / (L) Front Fender, Molding - Scratch - Medium / Bonnet, Headlight - Scratch - Small</p>
Frame Evaluation : A	Functional Evaluation : A
<p>Remarks Defects not found</p>	<p>Remarks Defects not found</p>
