## General Information

<b>Make</b>	Toyota	<b>Model</b>	Wigo
<b>YOM</b>	2024	<b>Odo Meter Reading</b>	46,432
<b>Registration No.</b>	FAQ4931	<b>Chassis No.</b>	MHKAA1BC7PJ008959
<b>CC</b>	1.0	<b>Transmission</b>	CVT
<b>Fuel Type</b>	Gas	<b>Type of Body</b>	Hatchback
<b>Colour</b>	Yellow

## Body / Panel Condition

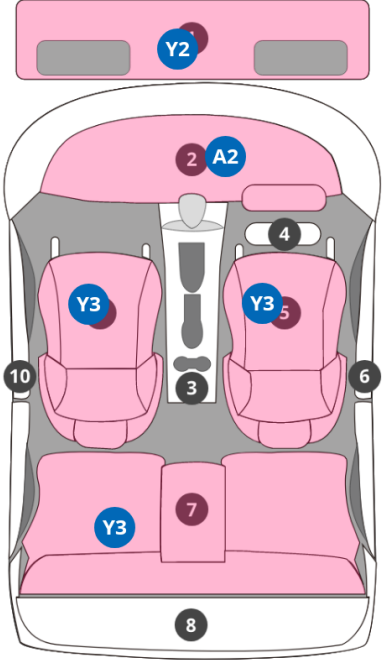
<b>Interior Evaluation :</b> <span style="float: right;"><b>B</b></span>	<b>Exterior Evaluation :</b> <span style="float: right;"><b>B</b></span>

<p><b>a</b> : Cut, Fray <b>d</b> : Loose, Deformed <b>k</b> : Animal Hair <b>s</b> : Smell <b>t</b> : Cigarette Burns <b>x</b> : Defective <b>y</b> : Stain</p>

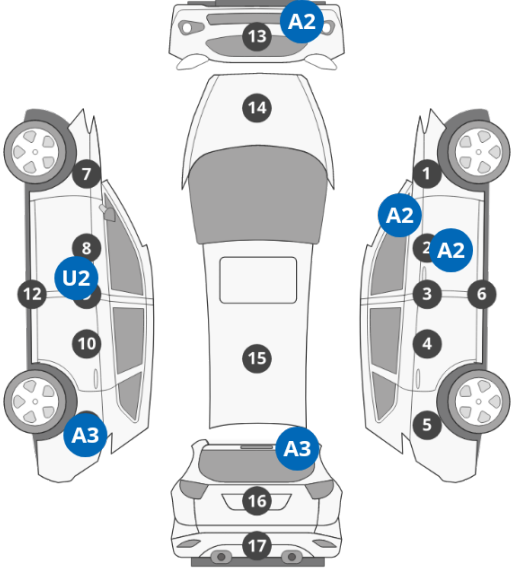
<p><b>A</b> : Scratch <b>AU</b> : Scratch &amp; Dent <b>B</b> : Modified <b>C</b> : Corrosion <b>G</b> : Stone chip <b>P</b> : Faded <b>S</b> : Rust <b>SC</b> : Rust &amp; Corrosion <b>U</b> : Dent <b>X</b> : Defective <b>Y</b> : Crack, Gap</p>
<b>Remarks</b> (L) Front Seat - Grime - Medium / (R) Front Seat - Grime - Medium / Rear Seat - Grime - Medium / Ceiling - Grime - Small / Dashboard - Worn, Scratch, Cut, Crack - Small	<b>Remarks</b> (R) Front Door, Molding - Scratch - Small / (L) Front Door, Molding - Dent - Small / Front Bumper, Grille, Lamps - Scratch - Small / (R) Mirror - Scratch - Small / Trunk Hood, Rear Gate - Scratch - Medium / (L) Rear Fender, Molding - Scratch - Medium
