## General Information

| Make | Toyota | Model | Vios |
| YOM | 2022 | Mileage | 31,679 |
| Registration No. | DBB4719 | Chassis No. | PA1B18F3XN4173650 |

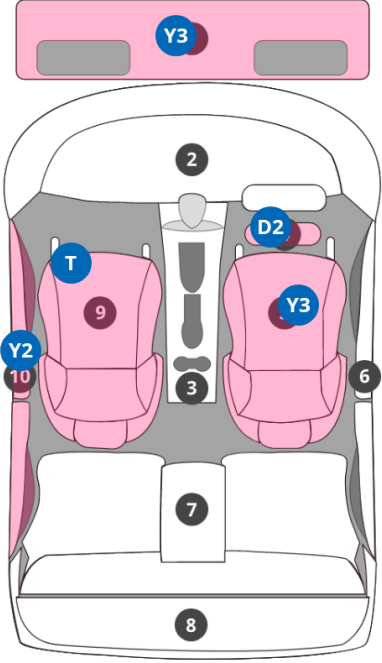
| Interior Evaluation : <span style="color: red;">C</span> | Exterior Evaluation : <span style="color: red;">E</span> |
| <p><b>Remarks</b><br/>(L) Front Seat - Cigarette Burns - Burnt, Hole / Ceiling - Grime - Medium / (R) Front Seat - Grime - Medium / (L) Front Floor Mat - Worked - Small / (L) Front Trim - Grime - Small</p> | <p><b>Remarks</b><br/>(R) Front Fender, Molding - Scratch - Small / (R) Front Door, Molding - Scratch &amp; Dent - Large / (R) Rear Door, Molding - Scratch - Large / (R) Rear Fender, Molding - Scratch - Small / Rear Bumper, Lamps, Panels - Scratch &amp; Dent - Medium / Trunk Hood, Rear Gate - Scratch &amp; Dent - Small / Roof - Scratch - Small / (L) Rear Fender, Molding - Scratch - Minimal / (L) Rear Door, Molding - Scratch - Minimal / (L) Front Door, Molding - Scratch - Small / (L) Front Fender, Molding - Scratch &amp; Dent - Medium / Member (Bolted) - Dent - Yes / Front Bumper, Grille, Lamps - Scratch - Medium / Bonnet, Headlight - Scratch - Medium</p> |

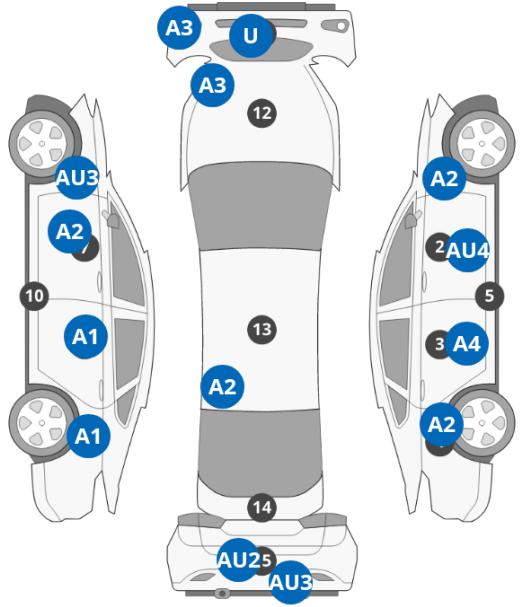
| Inspector Notes |
|---|
| with warranty booklet, with spare tire, with jack and tools, with LTO plate, crack on front bumper |
