General Information

Make	Toyota	Model	Hilux Tamaraw
YOM	2025	Odo Meter Reading	4,515
Registration No.	GBK5644	Chassis No.	PAHACACA8S6421394
CC	2.4	Transmission	M/T
Fuel Type	Diesel	Type of Body	Pickup
Colour	White

Body / Panel Condition

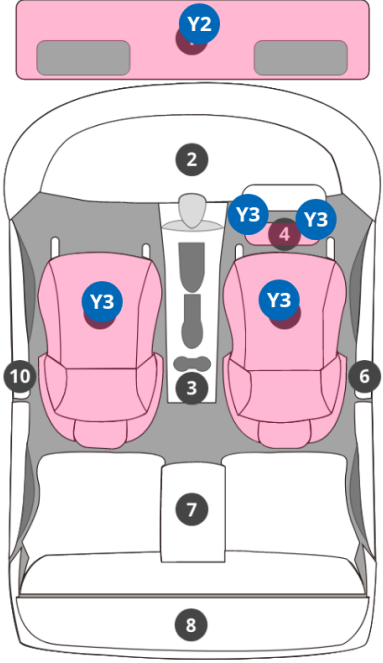
Interior Evaluation : B	Exterior Evaluation : E

<p>a : Cut, Fray d : Loose, Deformed k : Animal Hair s : Smell t : Cigarette Burns x : Defective y : Stain</p>

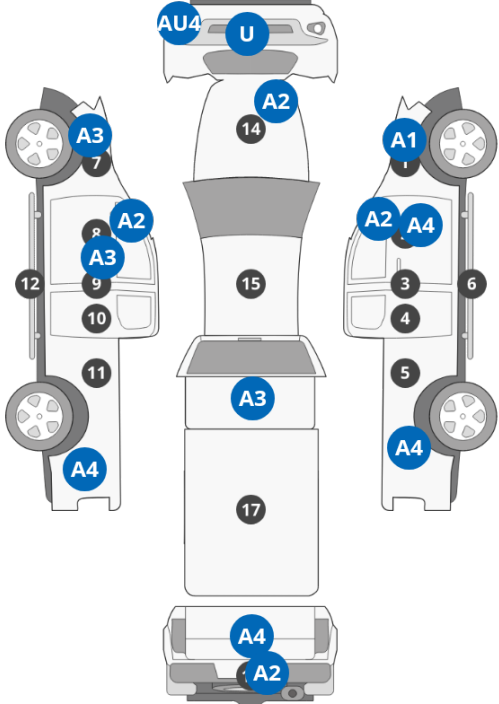
<p>A : Scratch AU : Scratch & Dent B : Modified C : Corrosion G : Stone chip P : Faded S : Rust SC : Rust & Corrosion U : Dent X : Defective Y : Crack, Gap</p>
<p>Remarks Ceiling - Grime - Small / (R) Front Seat - Grime - Medium / (R) Front Floor Mat - Grime - Medium / (L) Front Seat - Grime - Medium / (L) Front Floor Mat - Grime - Medium</p>	<p>Remarks Member (Bolted) - Dent - Yes / (L) Front Fender, Molding - Scratch - Medium / (L) Mirror - Scratch - Small / (L) Front Door, Molding - Scratch - Medium / (L) Side Gate - Scratch - Large / (R) Side Gate - Scratch - Large / Rear Gate - Scratch - Large / Rear Bumper, Lamps, Panels - Scratch - Small / (R) Front Door, Molding - Scratch - Large / (R) Mirror - Scratch - Small / (R) Front Fender, Molding - Scratch - Minimal / Bonnet, Headlight - Scratch - Small / Front Bumper, Grille, Lamps - Scratch & Dent - Large / Cab Back Panel - Scratch - Medium</p>

<p>Inspector Notes</p>
<p>Right reverse light busted. Gap at front bumper. Without warranty booklet and tools. With spare tire and jack. 1 key. With LTO plate.</p>
