General Information

Make	Toyota	Model	Innova
YOM	2022	Odo Meter Reading	16,097
Registration No.	EAE7143	Chassis No.	PA2JA8EM1N0102264
CC	2.8	Transmission	M/T
Fuel Type	Diesel	Type of Body	Wagon
Colour	Blackish Red Mica

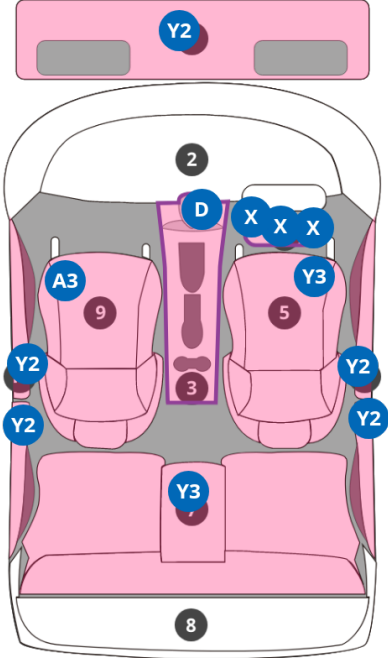
Interior Evaluation : C	Exterior Evaluation : E

<p>a : Cut, Fray d : Loose, Deformed k : Animal Hair s : Smell t : Cigarette Burns x : Defective y : Stain</p>

<p>A : Scratch AU : Scratch & Dent B : Modified C : Corrosion G : Stone chip P : Faded S : Rust SC : Rust & Corrosion U : Dent X : Defective Y : Crack, Gap</p>
<p>Remarks (R) Front Floor Mat - Missing - Yes / Mat Other - Missing - Yes / (L) Front Floor Mat - Missing - Yes / (R) Front Trim - Grime - Small / Console, Switches, Vents - Traces of Adhesive Tape - Yes / (R) Front Seat - Grime - Medium / (R) Rear Trim - Grime - Small / Ceiling - Grime - Small / (L) Rear Trim - Grime - Small / Rear Seat - Grime - Medium / (L) Front Seat - Cut, Crack - Medium / (L) Front Trim - Grime - Small / Room Mirror - Missing - Yes / Display, Audio System - Partially Missing - Yes</p>	<p>Remarks Bonnet, Headlight - Scratch & Dent - Small / Front Windshield - Damaged - Large / (L) Front Fender, Molding - Scratch - Medium / (L) Mirror - Scratch - Small / (L) Front Door, Molding - Scratch & Dent - Medium / (L) Rear Door, Molding - Scratch - Medium / (L) Rear Fender, Molding - Scratch & Dent - Medium / Trunk Hood, Rear Gate - Scratch & Dent - Medium / Rear Bumper, Lamps, Panels - Scratch - Large / (R) Rear Fender, Molding - Scratch & Dent - Medium / (R) Rear Door, Molding - Scratch & Dent - Medium / (R) Step, In-panel, Side Spoiler - Scratch & Dent - Medium / (R) Front Door, Molding - Scratch - Large / (R) Mirror - Scratch - Small / (R) Front Fender, Molding - Scratch - Medium / Front Bumper, Grille, Lamps - Modified - Medium / Front Bumper, Grille, Lamps - Scratch & Dent - Large / Roof - Scratch & Dent - Small</p>

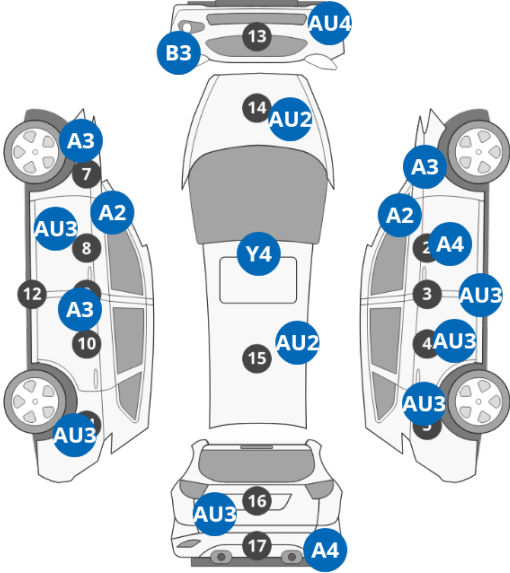
<p>Inspector Notes</p>
<p>Double registration with LTO apprehension. Possible flooding. Damaged front windshield. Rear view mirror missing. No reverse light. No Horn. Without warranty booklet, jack, tools and seat cover. With spare tire. 1 key. With LTO plate.</p>
